## Ron Walker Property Inspections

Member of NACHI  
[www.walkerinspects.com](http://www.walkerinspects.com)  
Licensed and Insured  
HI#732, HI#1143  
**Client(s):** Bob & Janet Jones  
**Property address:** 1234 Somewhere Avenue  
Miami, FL 33173  
**Inspection date:** 8/24/2011

This report published on Thursday, August 25, 2011 10:37:21 AM EDT

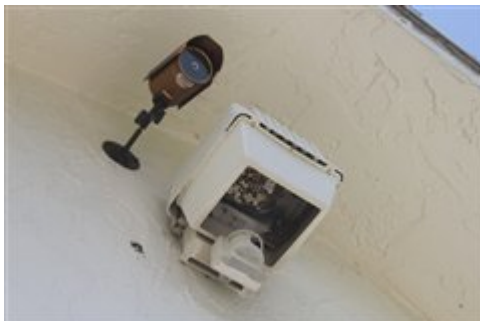
Photo 6

One or more hornet, bee or wasp nests were found at the building exterior. These can pose a safety hazard. A qualified person should remove nests or exterminate as necessary.

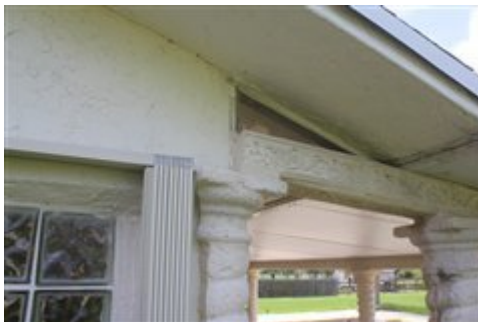
**Photo 54**

One or more patio screens were damaged. A qualified person should evaluate and repair or replace as necessary, and as per standard building practices.

*Cost estimate: \$ 50*

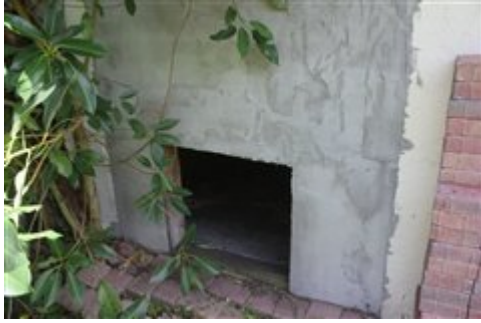
**Photo 91**

Vegetation such as trees, shrubs and/or vines was in contact with or less than one foot from the building exterior. Vegetation can serve as a conduit for wood destroying insects and may retain moisture against the exterior after it rains. Vegetation should be pruned and/or removed as necessary to maintain a one foot clearance between it and the building exterior.

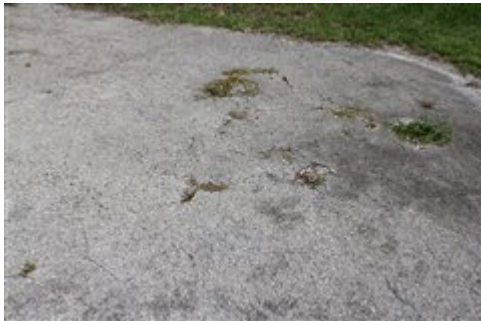
**Photo 55**

Recommend resealing asphalt driveway.

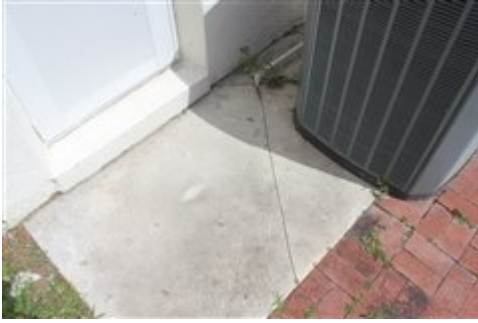
**Photo 20**

Minor cracks, settlement, heaving and/or deterioration were found in one or more sidewalk or patio sections. However they don't appear to be a structural concern and no trip hazards were found. No immediate action is recommended, but the client may wish to have repairs made or have cracked sections replaced for aesthetic reasons.

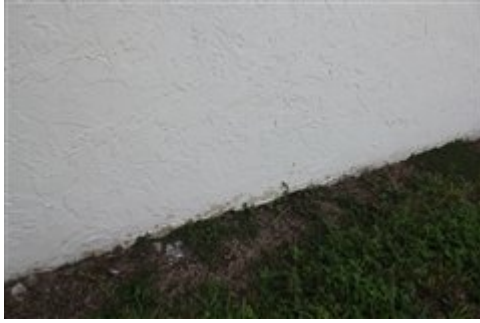
**Photo 113**

One or more pier or foundation footings were undermined, where soil has either eroded out from underneath, or has been excavated too close to the footing. Standard building practices typically require undisturbed soil to extend at least a foot horizontally out from the edge of footings, and then slope down no more steeply than 45 degrees. Otherwise soil may collapse from beneath the footing(s). A qualified contractor or engineer should evaluate and determine what repairs if any should be made. A qualified contractor should perform any repairs that may be needed. i.e. the Master Bathroom; this may be due to a past or present plumbing related issue

*Cost estimate: \$ 1,500*

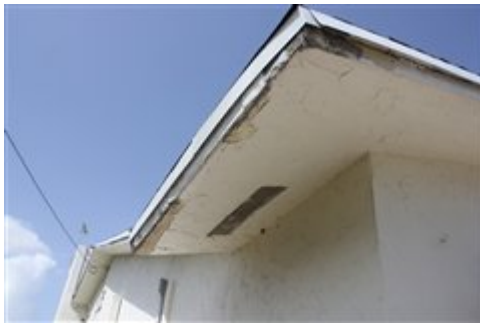
**Photo 7**

The exterior finish in some areas was failing. A qualified contractor should prep (pressure wash, scrape, sand, prime caulk, etc.) and repaint or restrain areas as needed and as per standard building practices.

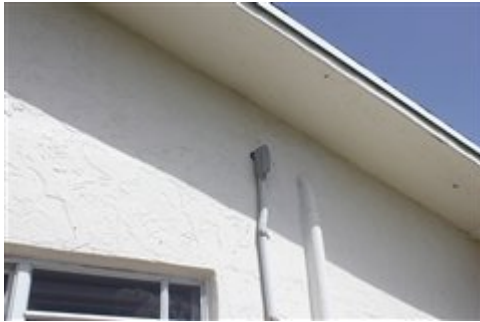
**Photo 18**

Cracks, deterioration and/or damage were found in one or more areas of the stucco. A qualified contractor should evaluate and make repairs to the stucco as necessary.

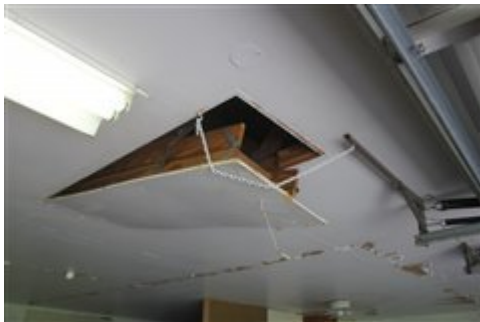
**Photo 95**

Attic access stairs were unsafe due to the following conditions: damaged. A qualified person should evaluate and repair or replace the stairs as necessary.

*Cost estimate: \$ 150*

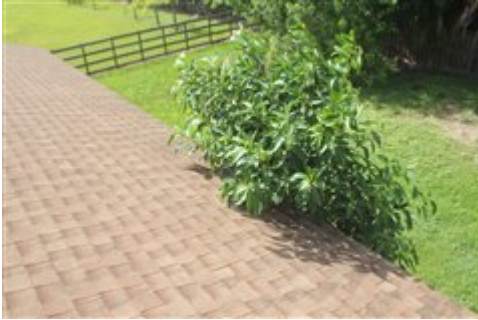
**Photo 92**

Trees were overhanging roof and were within 10 feet of roof vertically. This is a conducive condition for wood destroying insects and organisms since organic debris such as leaves or needles are more likely to accumulate on the roof surface. Accumulated debris may cause water to enter gaps in the roof surface and leak into attic and/or interior spaces. Trees should be pruned so they are at least 10 feet above roof, or don't overhang the roof.

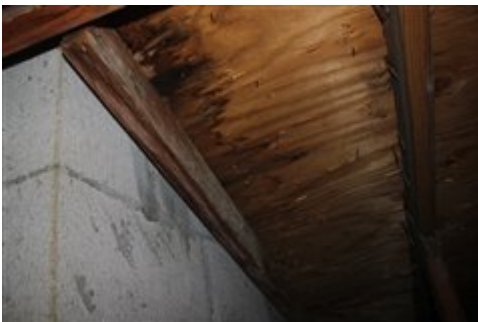
**Photo 183**

Stains were visible on the roof structure in one or more areas. These areas were dry at the time of the inspection. The stains may be caused by a past leak. Recommend asking the property owner about past leaks. The client should monitor these areas in the future, especially after heavy rains, to determine if active leaks exist. If leaks are found, a qualified contractor should evaluate and repair as necessary.

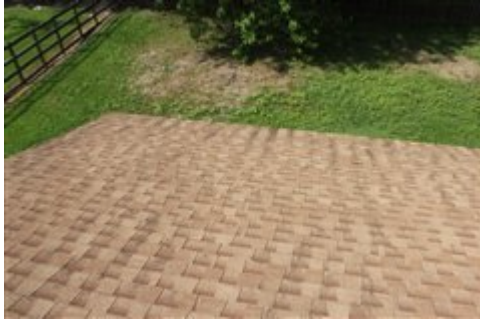
**Photo 94**

Roof starting to shows signs of aging; some composition shingles had the following conditions: granules worn away, deterioration. Leaks may occur as a result.

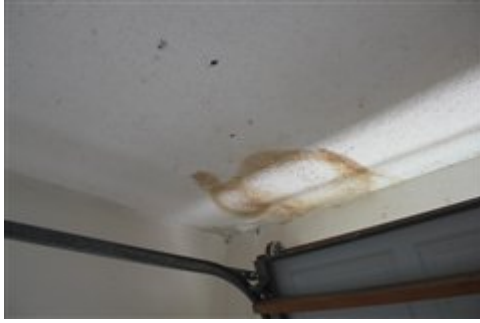
**Photo 101**

Stains were found in one or more ceiling areas. However, no elevated levels of moisture were found. The stain(s) may be due to past roof and/or plumbing leaks. Recommend asking the property owner about this, and monitoring the stained area(s) in the future, especially after heavy or prolonged rain. If elevated moisture is found in the future, a qualified contractor should evaluate and repair as necessary.

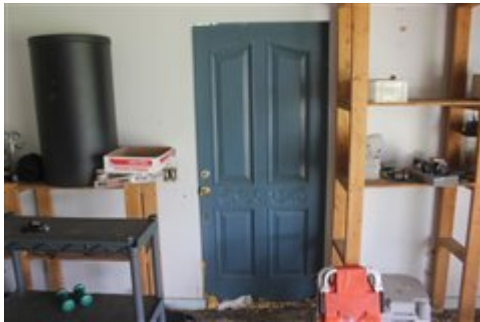
**Photo 57**

The side pedestrian door was damaged or deteriorated and sealed shut. A qualified contractor should replace or repair this door as necessary.

*Cost estimate: \$ 350*

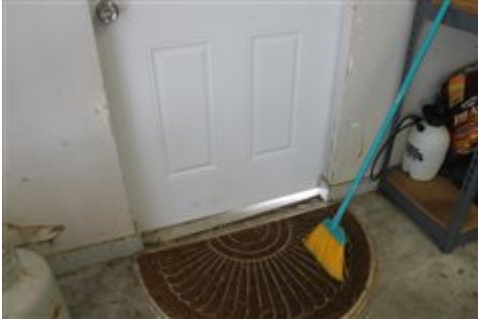
**Photo 80**

The weatherstrip on the side pedestrian door was deteriorated and the door was difficult to close and lock. A qualified contractor should evaluate and repair the lock and repair or replace the weatherstrip as necessary.

*Cost estimate: \$ 100*

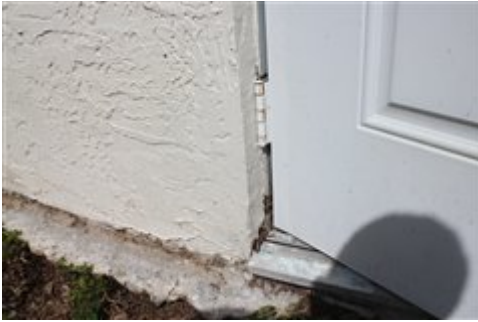
**Photo 86**

The door trim or jambs on the side pedestrian door was deteriorated. A qualified contractor should evaluate and repair or replace the trim or jambs as necessary.

*Cost estimate: \$ 50*

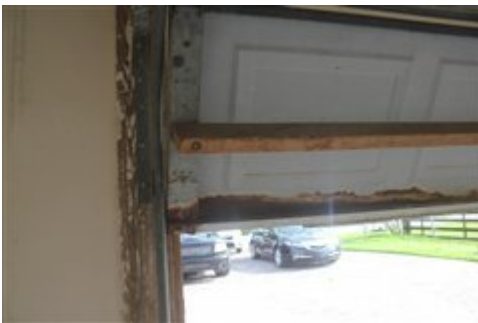
**Photo 179**

One or more vehicle doors were damaged or deteriorated. A qualified contractor should evaluate and repair or replace the door(s) as necessary.

*Cost estimate: \$ 2,000*

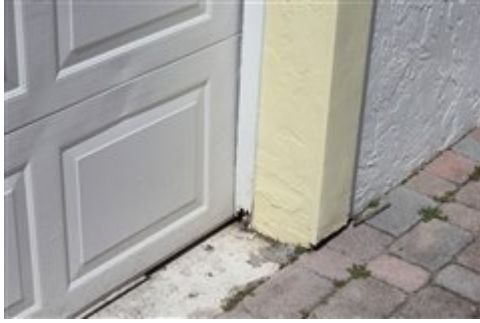
**Photo 5**

Trim on one or more vehicle doors was damaged or deteriorated. A qualified contractor should evaluate and repair or replace the door trim as necessary.

*Cost estimate: \$ 50*

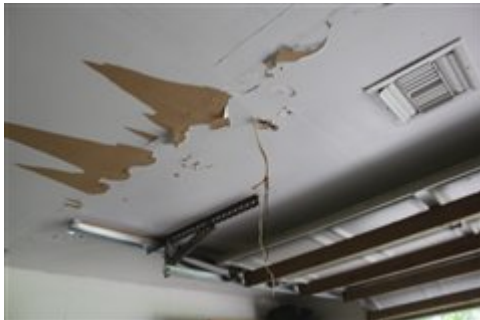
**Photo 59**

22) 🛠️ ⓘ Minor cracks, heaving, damage, and/or settlement were found in one or more sections of garage walls & ceilings. They do not appear to be a structural concern, but the client should repair these. Have a qualified contractor make repairs and re-paint the area after the repairs have been completed.

*Cost estimate: \$ 300*

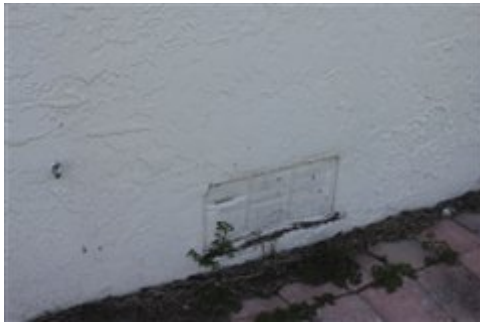
**Photo 70**

23) 🛠 Screens were missing or deteriorated at one or more garage vents. Birds and vermin may enter the garage because of this. A qualified person should replace screens as necessary.  
*Cost estimate: \$ 100*

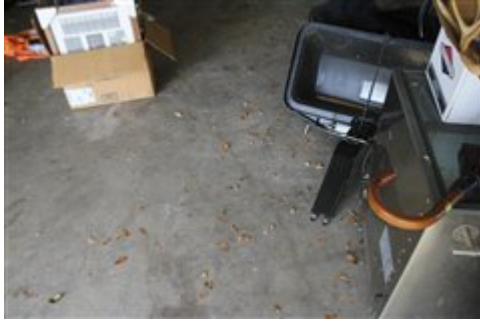
**Photo 61**

24) ⓘ Minor cracks, heaving and/or settlement were found in one or more sections of slab floors. They do not appear to be a structural concern, but the client may wish to repair these for aesthetic reasons.

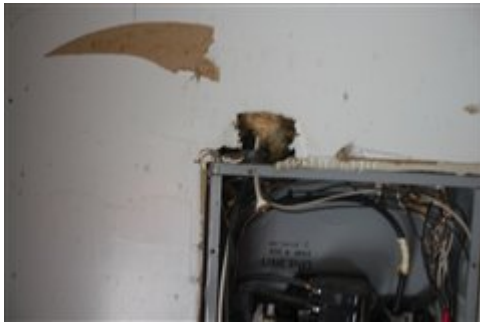
**Photo 65**

The dead front to panels #C & #D were installed so they were not flush with the surface of the panel box and disconnect devices. Gaps existed, resulting in exposed wiring. This is a safety hazard due to the risk of shock. A qualified electrical contractor should evaluate and repair as necessary  
*Cost estimate: \$ 350*

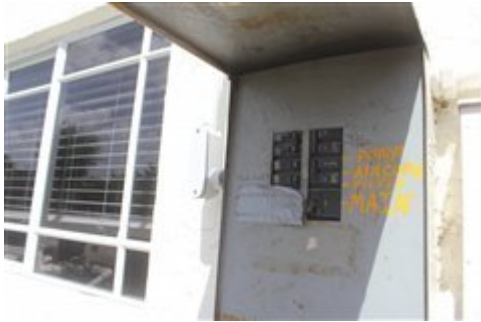
**Photo 11**

Breaker blank(s) missing at panel #A. This is a safety hazard for shock. A qualified electrician should replace missing components as necessary.  
*Cost estimate: \$ 100*

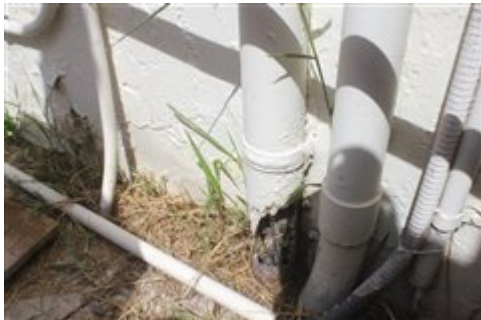
**Photo 8**

The electrical service piping was deteriorated and had exposed wiring. This is a safety hazard due to the risk of shock and fire. FPL or a qualified electrician should evaluate and repair as necessary.

*Cost estimate: \$ 300*

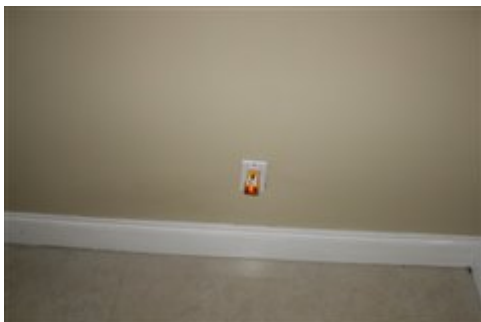
**Photo 128**

Some electric receptacles had reverse-polarity wiring, where the hot and neutral wires are reversed. This is a safety hazard due to the risk of shock. A qualified electrician should evaluate and make repairs as necessary.

*Cost estimate: \$ 300*

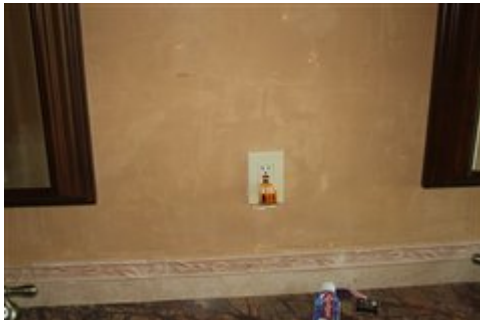
**Photo 117**

One or more ground fault circuit interrupter (GFCI) electric receptacles wouldn't reset at the following "wet" locations: bathroom(s). This is a safety hazard due to the risk of shock. A qualified electrician should evaluate and repair as necessary.

*Cost estimate: \$ 200*

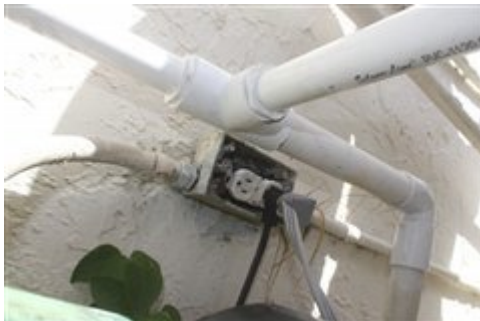
**Photo 16**

32) 🚑🔧🔍 One or more exterior receptacles have missing rain cover. This is a safety hazard for shock. A qualified person should replace missing components as necessary.  
*Cost estimate: \$ 100*

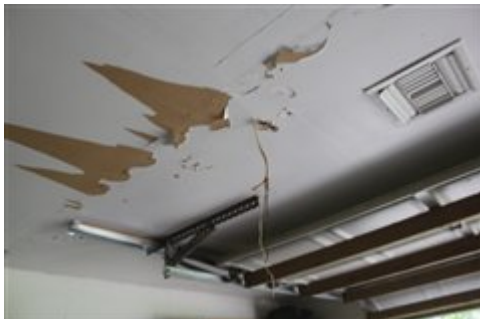
**Photo 59**

34) 🚑🔧🔍 Many light fixtures were missing, loose. A qualified person should evaluate and repair or replace as necessary.

*Cost estimate: \$ 400*

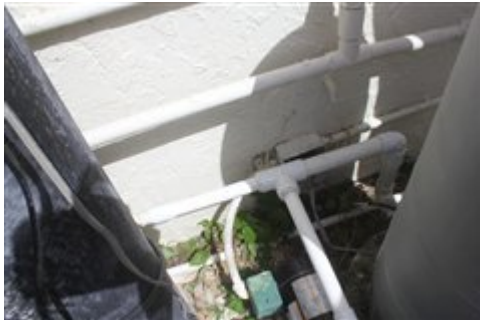
**Photo 17**

One or more junction box(es) used at the building exterior were missing components or had loose or exposed wiring. This is a potential safety hazard for shock and/or fire. A qualified electrician should evaluate and repair as necessary.

*Cost estimate: \$ 100*

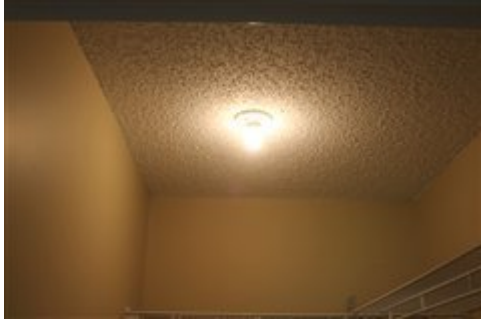
**Photo 130**

Lamp holders or light fixtures with fully or partially exposed bulbs were installed in one or more closets. This is a safety hazard due to the risk of fire. Flammable stored items may come into contact with hot bulbs, and hot fragments from broken bulbs may fall on combustible materials. Standard building practices require closet lighting to use fluorescent light fixtures, or to use fully enclosed incandescent fixtures. Installing a compact fluorescent lamp in a lamp holder is not an acceptable practice. A qualified electrician should replace closet lights as necessary and as per standard building practices.

*Cost estimate: \$ 100*

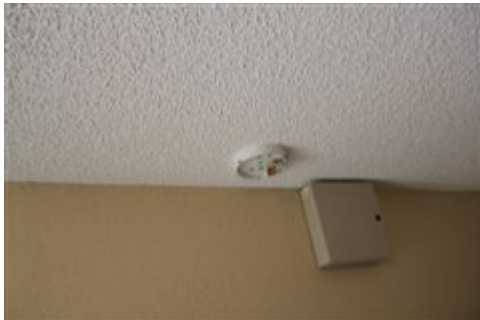
**Photo 174**

Smoke detectors were missing from bedrooms, from hallways leading to bedrooms. Additional smoke detectors should be installed as necessary so a functioning one exists in each hallway leading to bedrooms, in each bedroom, and one each level of the building. For more information, visit: <http://www.cpsc.gov/cpsc/pub/pubs/5077.html>  
*Cost estimate: \$ 150*

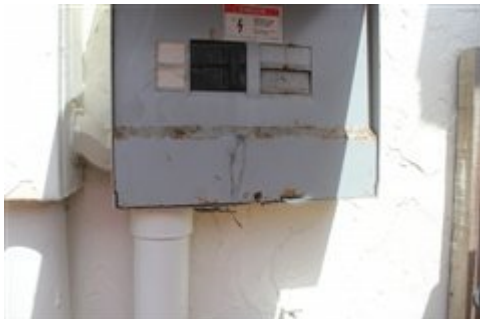
**Photo 9**

One or more screws were missing from the dead front to panels #A & #B and should be replaced. Because energized wiring may exist behind the holes with the missing screws, recommend that a qualified, licensed electrician replace these screws, or that care be taken to ensure that the new screws do not come in contact with wiring inside the panel when they are installed. Stock screws from the panel manufacturer should be used, or their equivalent.

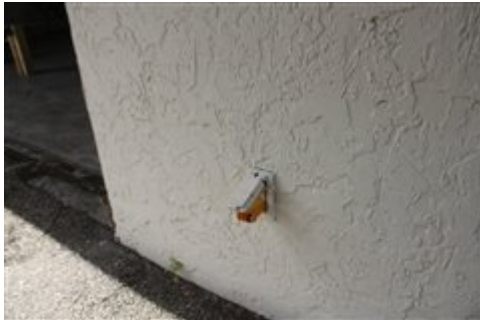
**Photo 66**

40) 🔧🔍 One or more electric receptacles appeared to have no power. Recommend asking the property owner about this. Switches may need to be operated to make some receptacles energized. If necessary, a qualified electrician should evaluate and make repairs as necessary.  
*Cost estimate: \$ 300*

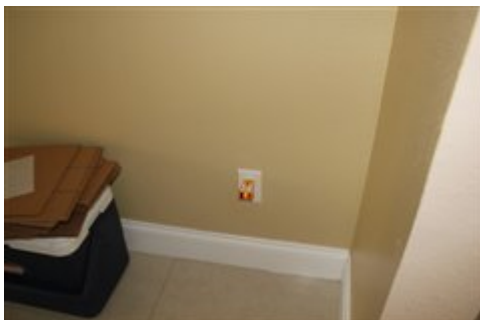
**Photo 141**

41) 🔧🔍 Numerous open ground, three-pronged electric receptacles were found. This is a safety hazard due to the risk of shock. A qualified electrician should evaluate and make repairs as necessary. For example, replacing receptacles or correcting wiring circuits.  
*Cost estimate: \$ 300*

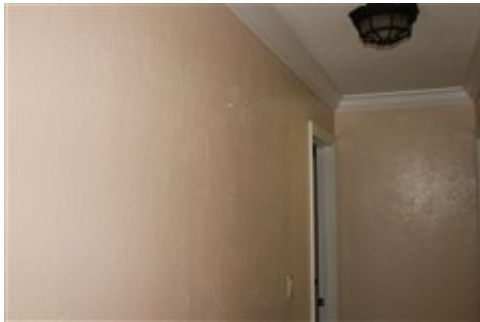
**Photo 134**

42) 🔧🔍 One or more three-way light switches appear to be incorrectly wired, so the light(s) don't operate correctly. A qualified electrician should evaluate and repair as necessary.  
*Cost estimate: \$ 100*

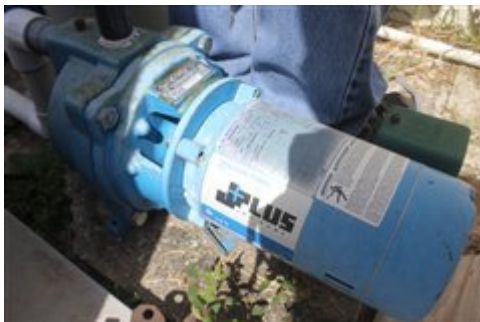
**Photo 13**

43) 🔧🔍 The house water supply pump and pool pump appear to be missing the grounding wire for the pumps. Have a qualified electrician evaluate and make the appropriate repair or replacement.  
*Cost estimate: \$ 75*

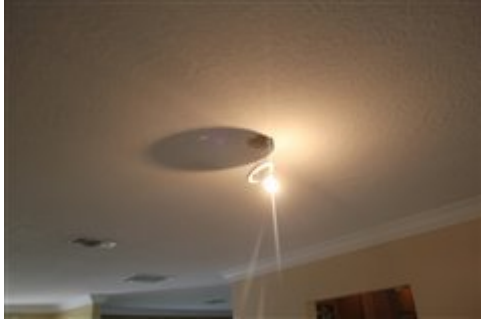
**Photo 143**

44) 🔧🔍 One or more lamp covers were missing and should be replaced as necessary.  
*Cost estimate: \$ 100*

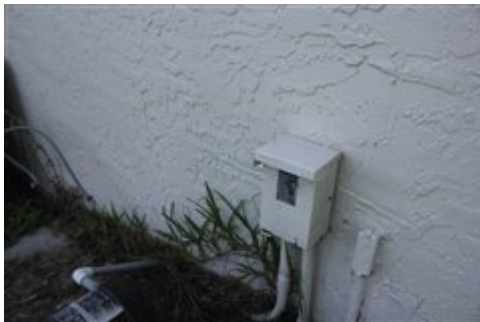
**Photo 73**

48) 🚑🔍 Cover for sprinkler power switch at rear garage was damaged. Have a qualified electrician evaluate and make the appropriate repair.

*Cost estimate: \$ 100*

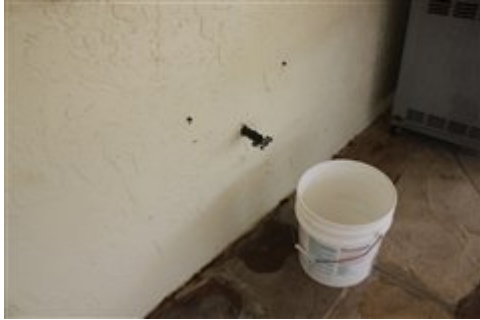
**Photo 37**

49) 🚑🔧 One or more outside faucets were missing backflow prevention devices. These devices reduce the likelihood of polluted or contaminated water entering the potable water supply. This condition can occur when an outside faucet is left in the "on" position with a hose connected and the sprayer head turned off. When pressure in the system fluctuates, water can be drawn back into the water supply pipes from the building. If a chemical sprayer is being used with the hose, those chemicals can enter the water supply pipes. Recommend installing backflow prevention devices on all exterior hose bibs where missing. They are available at most home improvement stores and are easily installed.

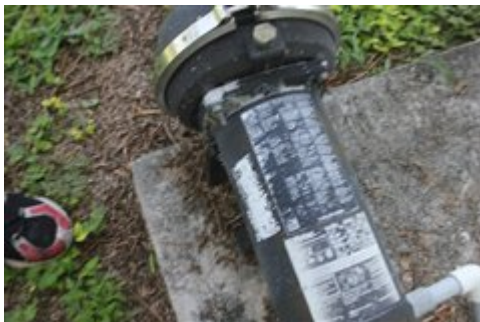
**Photo 72**

50) 🔧🔍 Sprinkler motor was not operating and needs to be replaced. Have a qualified person evaluate and replace motor. Note: The sprinkler system could not be evaluated.  
*Cost estimate: \$ 400*

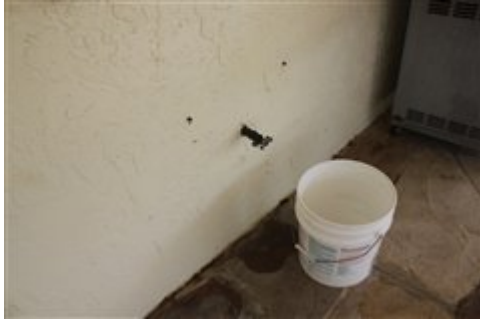
**Photo 37**

51) 🔧 The handles at one or more outside faucets were broken. A qualified plumber should repair or replace as necessary.  
*Cost estimate: \$ 50*

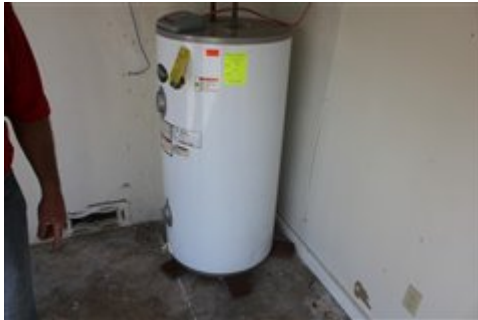
**Photo 100**

Temperature-pressure relief valve drain line was too short. This is a potential safety hazard due to the risk of scalding if someone is standing next to the water heater when the valve opens. A qualified plumber should extend the drain line to 6 inches from the floor, or route it so as to drain outside.

*Cost estimate: \$ 100*

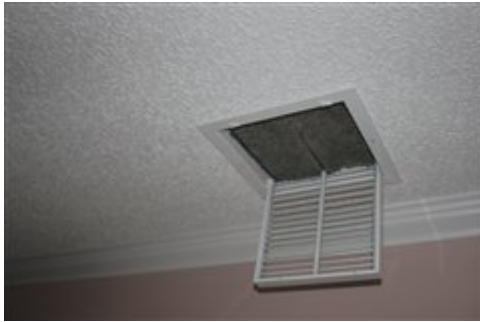
**Photo 127**

One or more air filters were dirty. A qualified person should replace filter(s) as necessary. Filters should be checked monthly and maintained as necessary in the future.

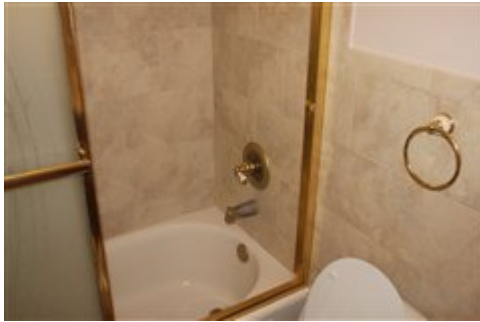
**Photo 140**

There was either no water, or a low flow from the hot, cold water faucet at the bathtub at location #B. A qualified person should evaluate and repair as necessary.  
*Cost estimate: \$ 300*

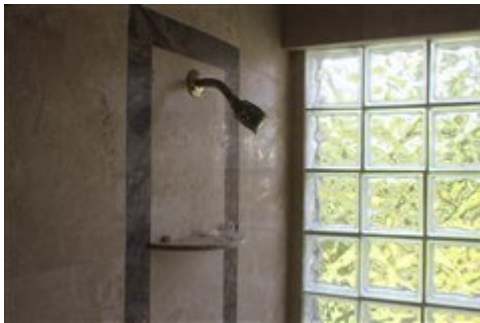
**Photo 122**

There was either no water, or a low flow from the hot, cold water faucet at the shower at location #A. A qualified person should evaluate and repair as necessary.  
*Cost estimate: \$ 300*

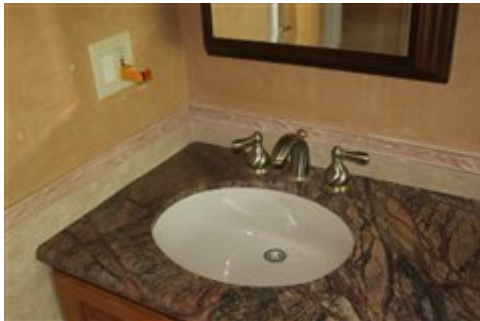
**Photo 119**

One or more sink faucet handles at location #A were loose. The sink on the left side control valves were installed in a reverse. A qualified plumber should repair or replace as necessary.  
*Cost estimate: \$ 400*

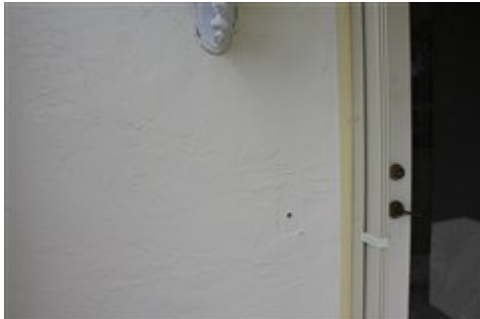
**Photo 115**

The front door's doorbell button was missing. A qualified person should repair or install as necessary.

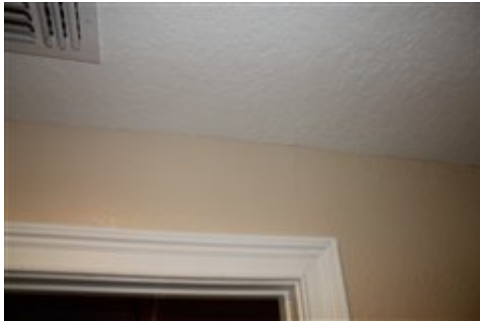
**Photo 167**

77) 🛠️ Minor cracks and/or holes were found in walls in one or more areas. They do not appear to be a structural concern, but the client may wish to repair these for aesthetic reasons.

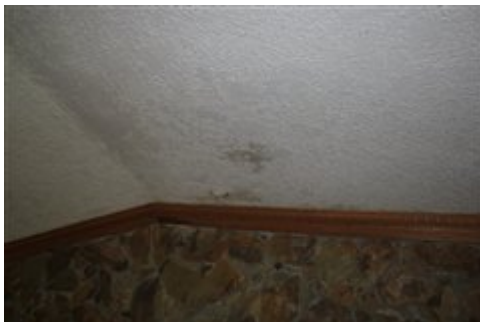
**Photo 157**

78) 🏠 Stains were found in one or more ceiling areas. However, no elevated levels of moisture were found. The stain(s) may be due to past roof and/or plumbing leaks. Recommend asking the property owner about this, and monitoring the stained area(s) in the future, especially after heavy or prolonged rain. If elevated moisture is found in the future, a qualified contractor should evaluate and repair as necessary.

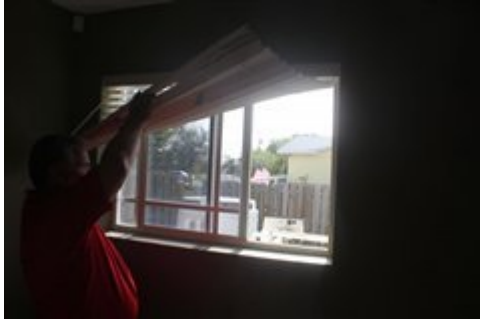
**Photo 165**

79) 📍 Screens in some windows were missing.

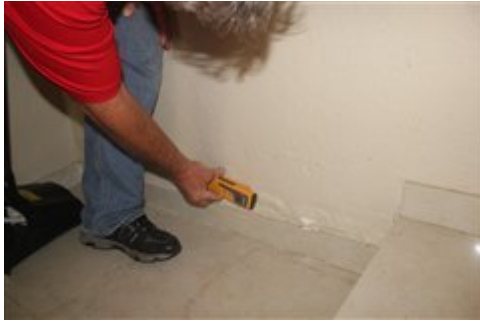
**Photo 172**

Note: Moisture left unattended for more than 72 hours can lead to mold growth. If evidence of mold is located inside the wall cavity, then mold assessment, testing and remediation steps will need to be taken at additional cost.

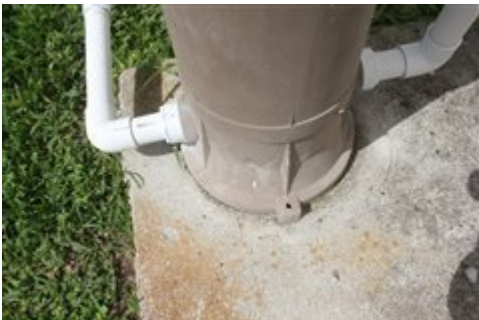
**Photo 24**

Pool filter was loose and should be secured by a qualified person.  
*Cost estimate: \$ 75*

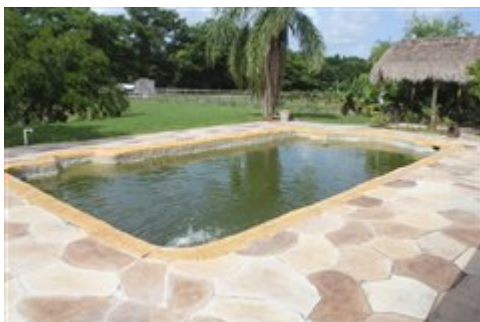
**Photo 96**

The pool body nor the pool light was not fully evaluated because the water was cloudy and obscured the bottom, significant amounts of debris, sediment or algae were present. Recommend that a qualified person fully evaluate the spa after it is made accessible and free from obstructions.
