## Ron Walker Property Inspections

Member of NACHI  
[www.walkerinspects.com](http://www.walkerinspects.com)  
Licensed and Insured  
HI#732, HI#1143  
**Client(s):** Bob & Janet Jones  
**Property address:** 1234 Somewhere Avenue  
Miami, FL 33173  
**Inspection date:** 8/24/2011

This report published on Thursday, August 25, 2011 10:37:21 AM EDT

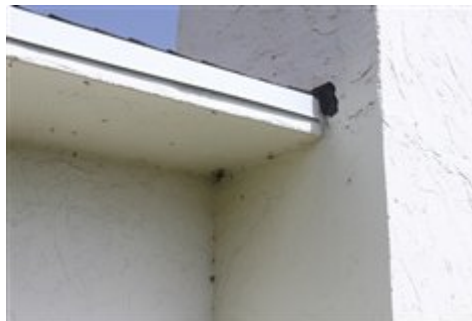
Photo 27

One or more hornet, bee or wasp nests were found at the building exterior. These can pose a safety hazard. A qualified person should remove nests or exterminate as necessary.

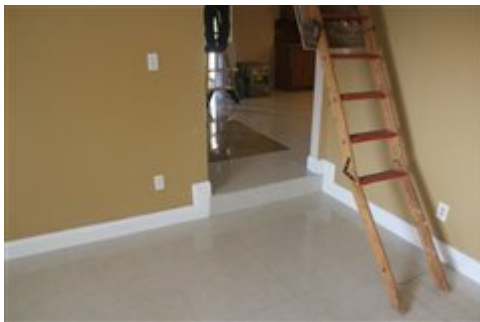
**Photo 163**

Based on substandard construction observed, modifications to this property may have been made without the owner having attained permits or inspections from the municipality. Work may have been performed by someone other than a qualified contractor or person. The client should consult with the property owner about this, and if necessary research permits.

At worst case, if substantial work was performed without permits, this knowledge must be disclosed when the building is sold in the future. This can adversely affect future sales. Also, the local municipality could require costly alterations to bring the building into legal compliance or even require that the additions or modifications be removed. This was in reference to the enclosed garage.

Note: Costs vary and may require an engineer to verify the construction was properly completed.

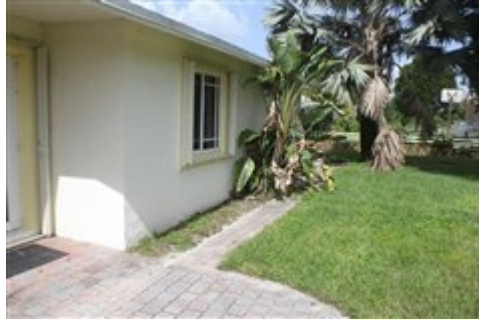
**Photo 110**

Vegetation such as trees, shrubs and/or vines was in contact with or less than one foot from the building exterior. Vegetation can serve as a conduit for wood destroying insects and may retain moisture against the exterior after it rains. Vegetation should be pruned and/or removed as necessary to maintain a one foot clearance between it and the building exterior.

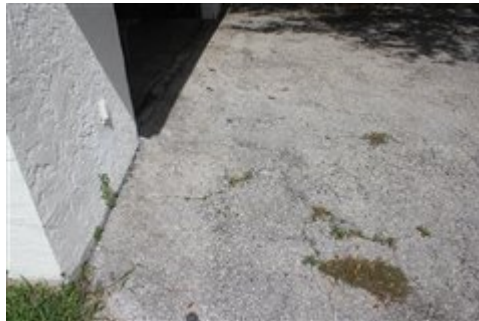
**Photo 56**

Recommend resealing asphalt driveway.

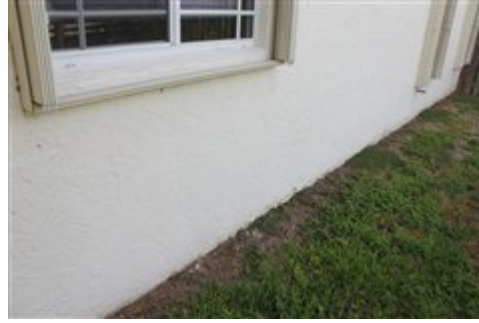
**Photo 114**

One or more pier or foundation footings were undermined, where soil has either eroded out from underneath, or has been excavated too close to the footing. Standard building practices typically require undisturbed soil to extend at least a foot horizontally out from the edge of footings, and then slope down no more steeply than 45 degrees. Otherwise soil may collapse from beneath the footing(s). A qualified contractor or engineer should evaluate and determine what repairs if any should be made. A qualified contractor should perform any repairs that may be needed. i.e. the Master Bathroom; this may be due to a past or present plumbing related issue

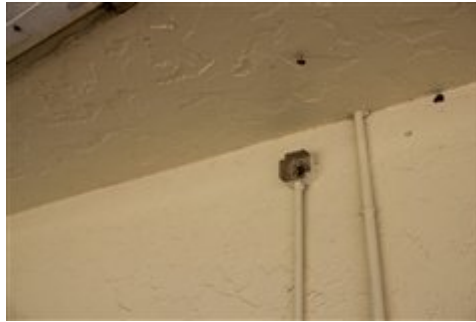
**Photo 40**

Cracks, deterioration and/or damage were found in one or more areas of the stucco. A qualified contractor should evaluate and make repairs to the stucco as necessary.

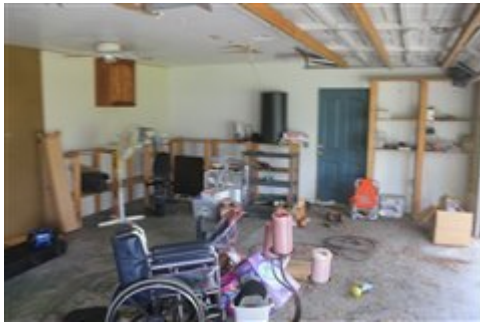
**Photo 62**

Some wall areas were obscured by stored items and couldn't be evaluated. These areas are excluded from the inspection.

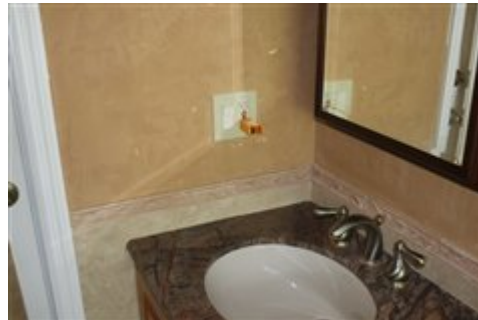
**Photo 118**

One or more ground fault circuit interrupter (GFCI) electric receptacles wouldn't reset at the following "wet" locations: bathroom(s). This is a safety hazard due to the risk of shock. A qualified electrician should evaluate and repair as necessary.

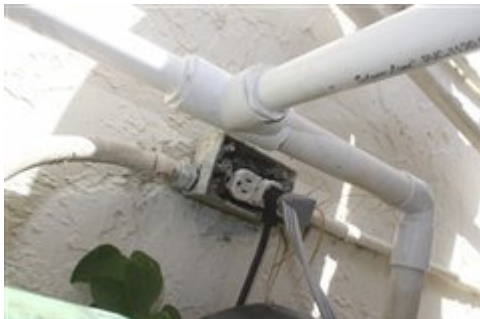
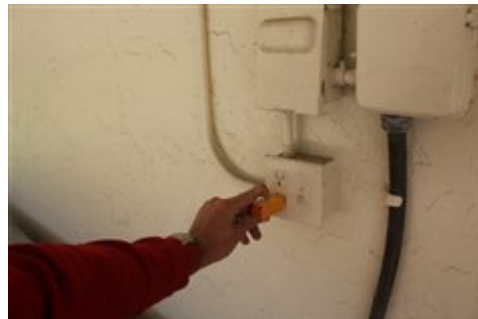
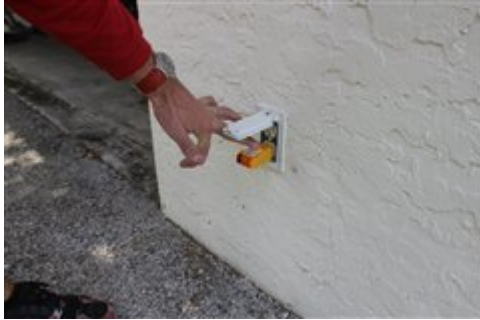
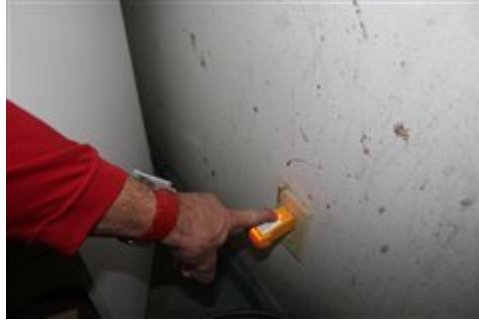
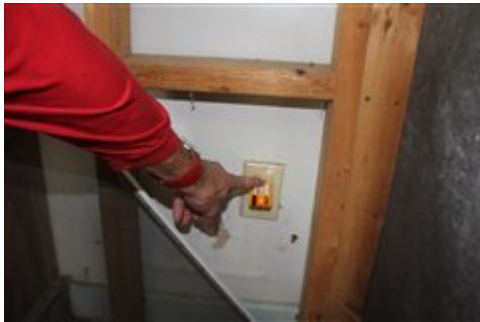
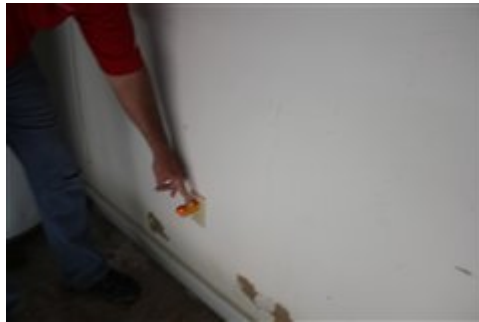
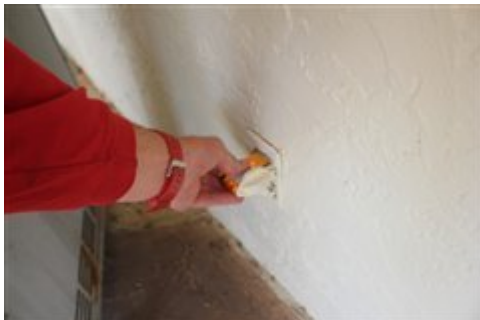
One or more electric receptacles at the garage, exterior had no visible ground fault circuit interrupter (GFCI) protection. This is a safety hazard due to the risk of shock. A qualified electrician should evaluate to determine if GFCI protection exists, and if not, repair as necessary. For more information, visit:

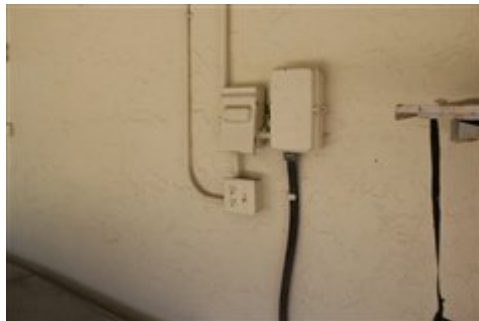
**Photo 39**

32) 🚑🔧🔍 One or more exterior receptacles have missing rain cover. This is a safety hazard for shock. A qualified person should replace missing components as necessary.  
*Cost estimate: \$ 100*

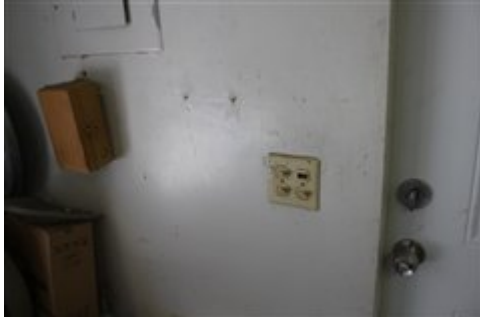
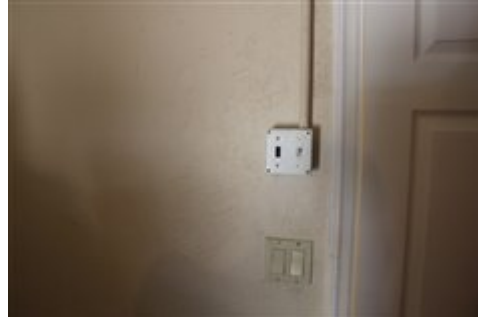
33) 🚑🔧🔍 Some switches were damaged. This is a safety hazard due to the risk of shock and fire. A qualified electrician should evaluate and repair or replace as necessary.

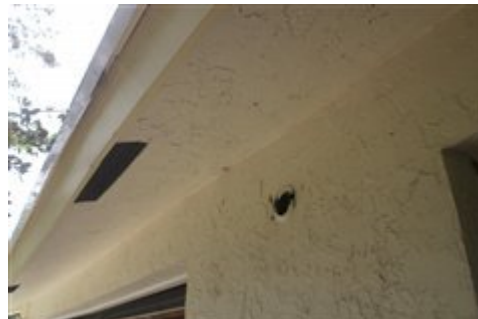
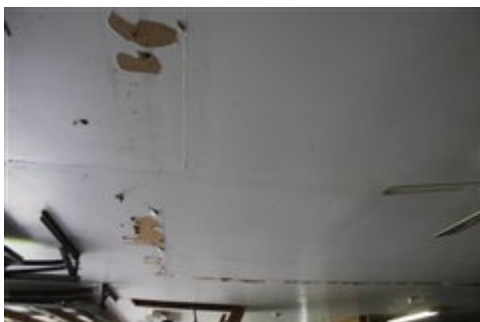
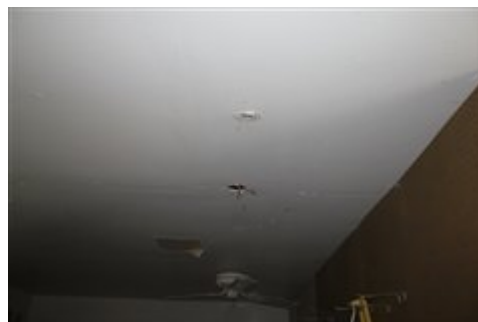
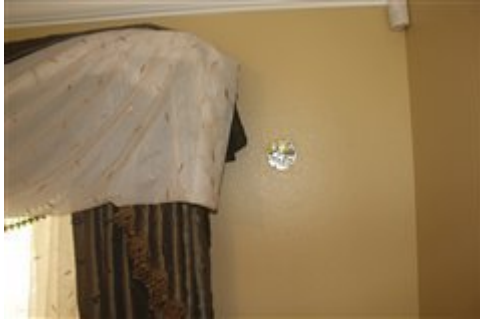
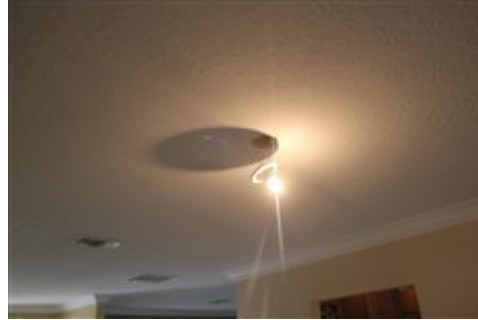
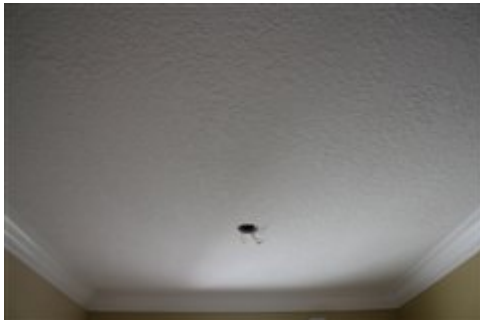
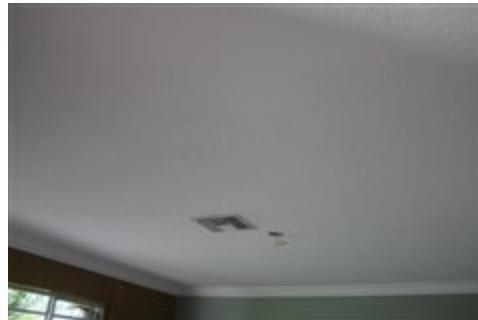
34) 🚑🔧🔍 Many light fixtures were missing, loose. A qualified person should evaluate and repair or replace as necessary.

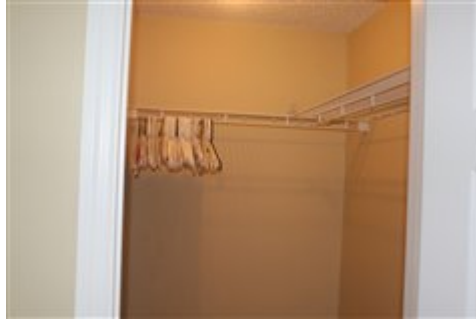
**Photo 131**

Lamp holders or light fixtures with fully or partially exposed bulbs were installed in one or more closets. This is a safety hazard due to the risk of fire. Flammable stored items may come into contact with hot bulbs, and hot fragments from broken bulbs may fall on combustible materials. Standard building practices require closet lighting to use fluorescent light fixtures, or to use fully enclosed incandescent fixtures. Installing a compact fluorescent lamp in a lamp holder is not an acceptable practice. A qualified electrician should replace closet lights as necessary and as per standard building practices.

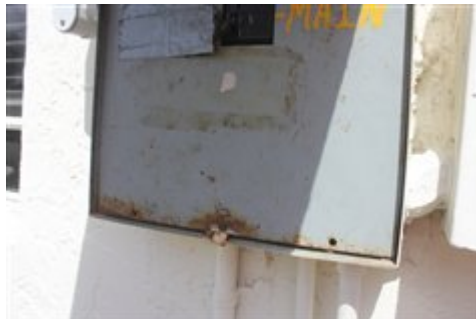
**Photo 10**

One or more screws were missing from the dead front to panels #A & #B and should be replaced. Because energized wiring may exist behind the holes with the missing screws, recommend that a qualified, licensed electrician replace these screws, or that care be taken to ensure that the new screws do not come in contact with wiring inside the panel when they are installed. Stock screws from the panel manufacturer should be used, or their equivalent.

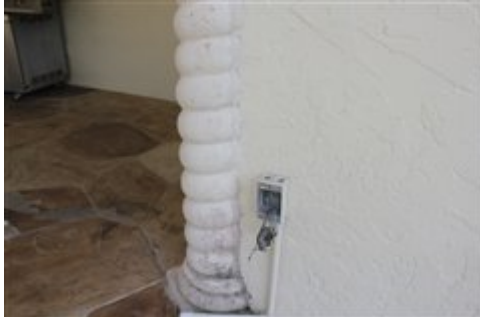
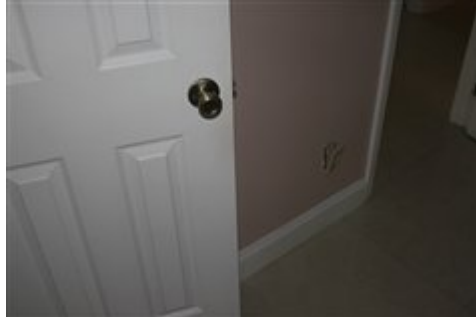
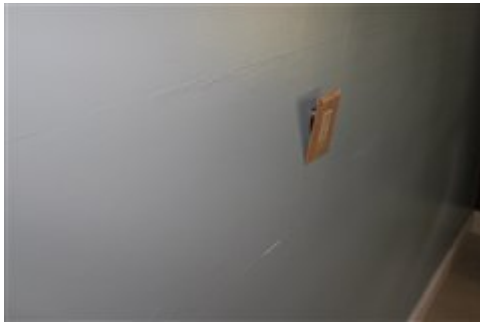
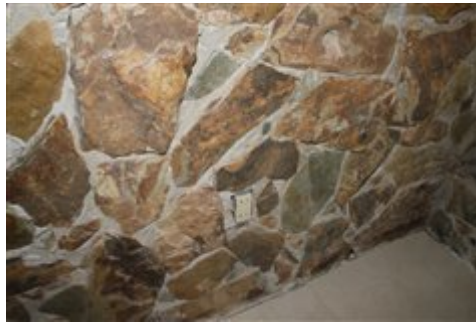
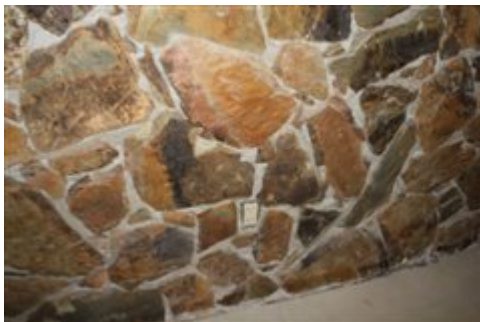
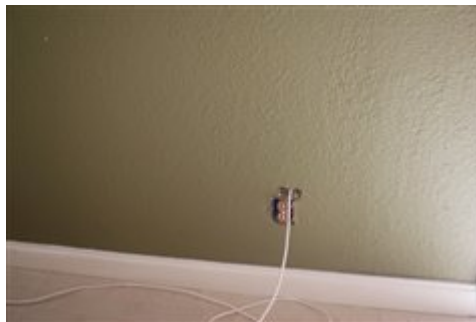
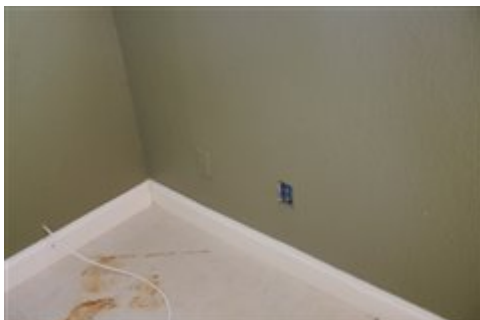
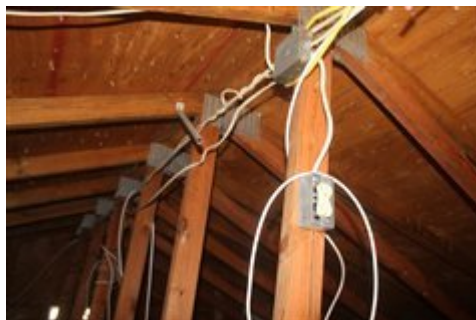
Some receptacle, junction box cover plates were missing, loose. They are intended to contain fire and prevent electric shock from exposed wires. This is a safety hazard due to the risk of fire and shock. A qualified electrician should repair as necessary.

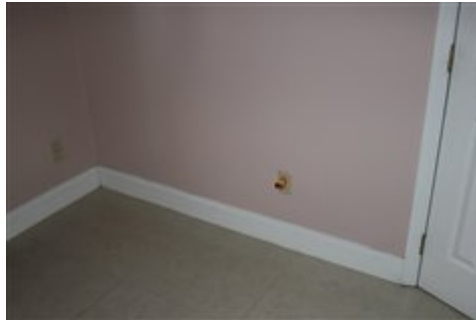
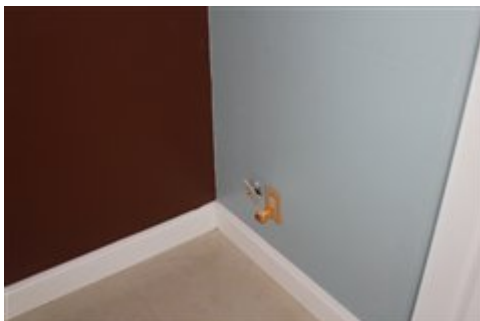
40) 🔧🔍 One or more electric receptacles appeared to have no power. Recommend asking the property owner about this. Switches may need to be operated to make some receptacles energized. If necessary, a qualified electrician should evaluate and make repairs as necessary.  
*Cost estimate: \$ 300*

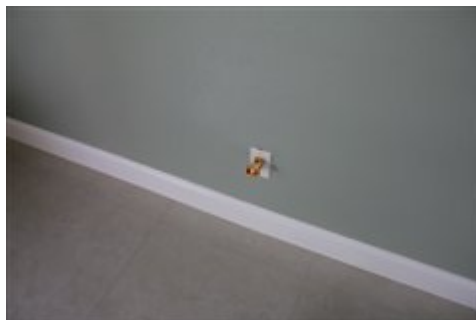
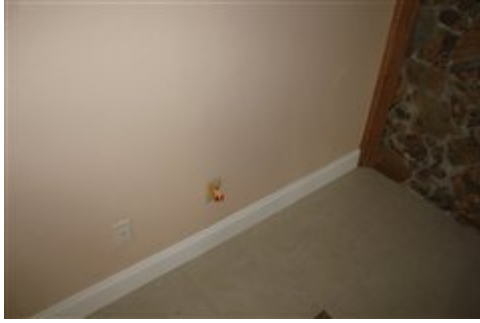
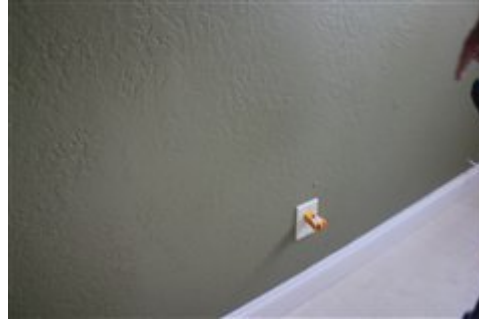
41) 🔧🔍 Numerous open ground, three-pronged electric receptacles were found. This is a safety hazard due to the risk of shock. A qualified electrician should evaluate and make repairs as necessary. For example, replacing receptacles or correcting wiring circuits.  
*Cost estimate: \$ 300*

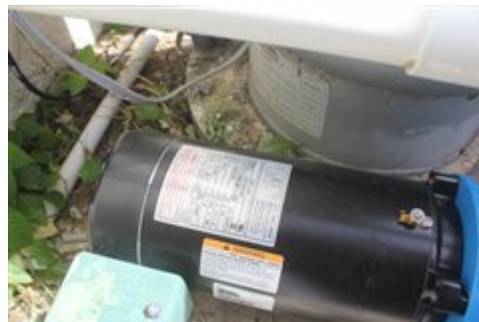
**Photo 15**

43) 🔧🔍 The house water supply pump and pool pump appear to be missing the grounding wire for the pumps. Have a qualified electrician evaluate and make the appropriate repair or replacement.  
*Cost estimate: \$ 75*

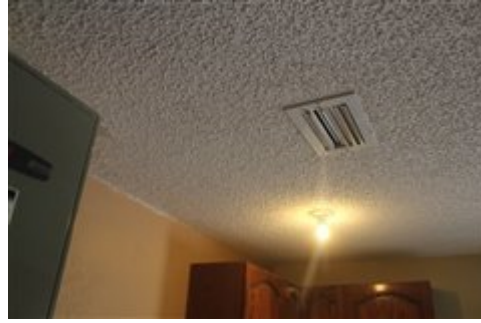
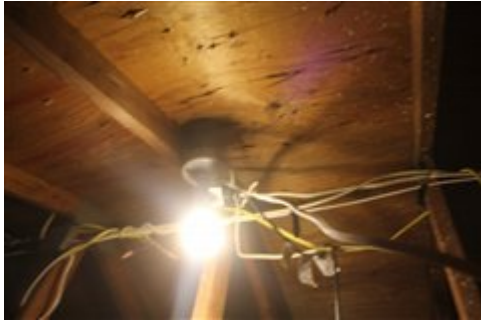
44) 🔧🔍 One or more lamp covers were missing and should be replaced as necessary.  
*Cost estimate: \$ 100*

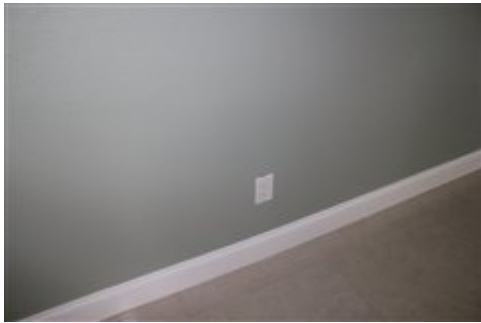
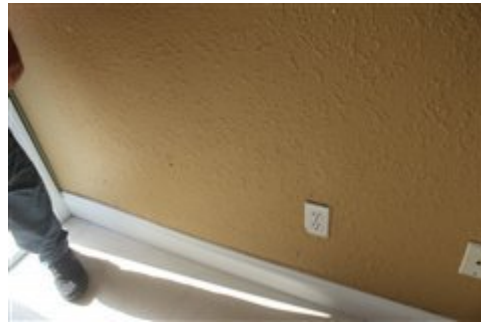
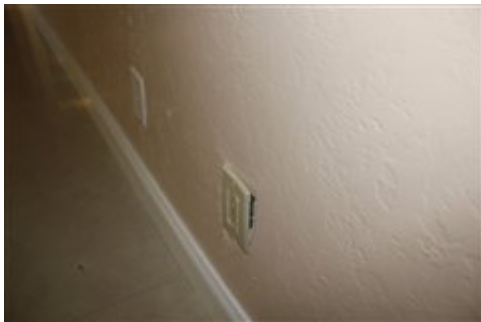
Gaps in wall surface materials existed around the edges of one or more cover plates to electric boxes.

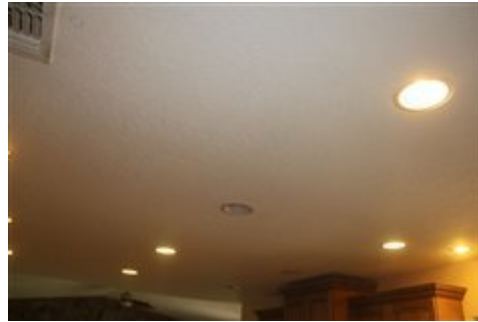
Photo 151

Some bulbs in light fixtures were missing, inoperable. As a result, some light fixtures couldn't be fully evaluated. Recommend replacing bulbs to fully evaluate fixtures where necessary.

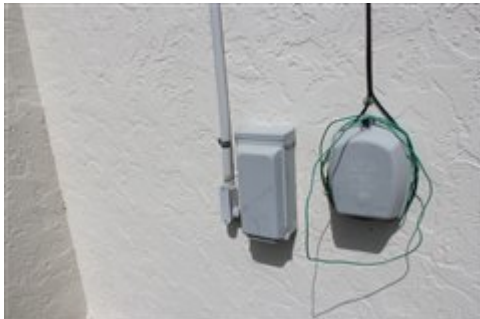
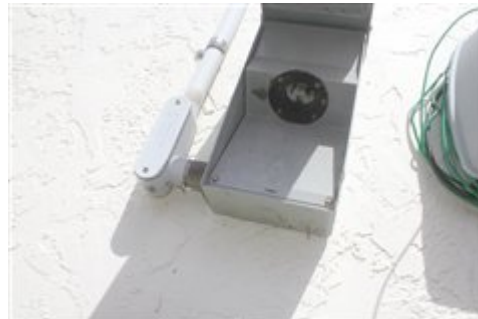
Property was equipped with a generator plug-in location for generating power to the home. A portable generator was located in the garage, but it was not inspected or tested for operation.

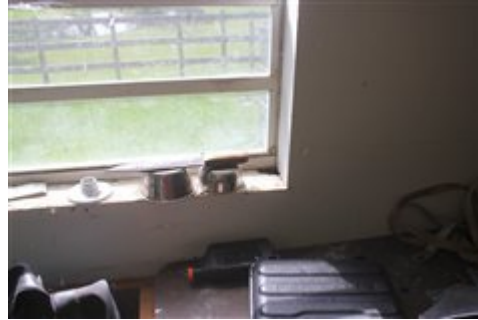
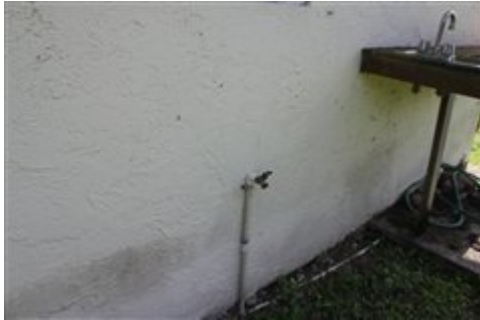
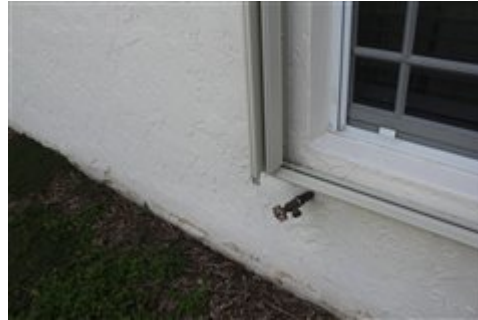
49) 🚑🔧 One or more outside faucets were missing backflow prevention devices. These devices reduce the likelihood of polluted or contaminated water entering the potable water supply. This condition can occur when an outside faucet is left in the "on" position with a hose connected and the sprayer head turned off. When pressure in the system fluctuates, water can be drawn back into the water supply pipes from the building. If a chemical sprayer is being used with the hose, those chemicals can enter the water supply pipes. Recommend installing backflow prevention devices on all exterior hose bibs where missing. They are available at most home improvement stores and are easily installed.

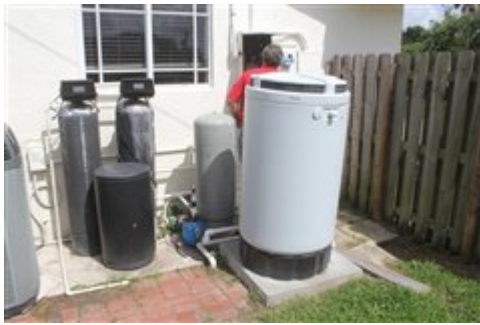
**Photo 14**

53) **i** The home has a whole house water softener system that was not evaluated. The client should consider having a water softener qualified contractor evaluate and explain the operation and maintenance of the system.

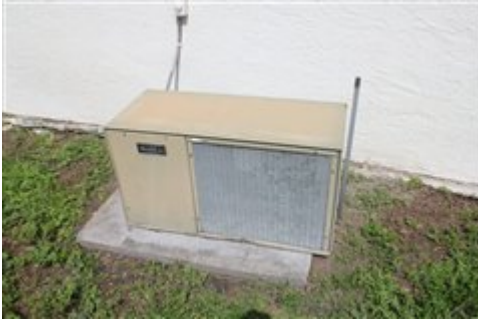
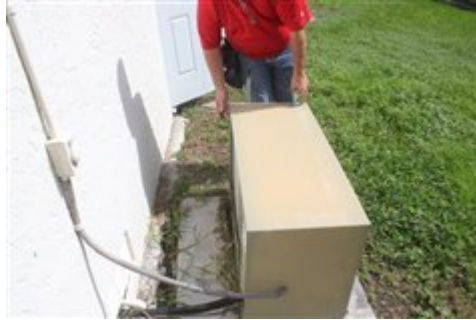
Motor was frozen on the rear garage system. System was also loose and needs to be secured. Based upon the age and condition of the system it is recommended it be replaced.

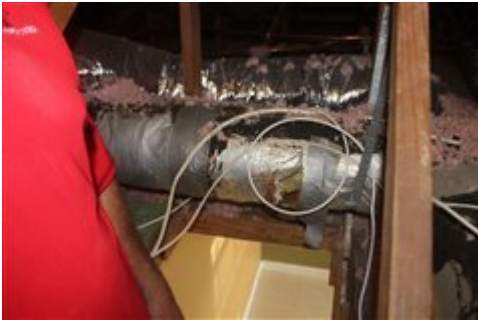
**Photo 184**

Some of the insulation on distribution ducts in the attic was damaged. A qualified person should evaluate and replace or repair as necessary for better energy efficiency.

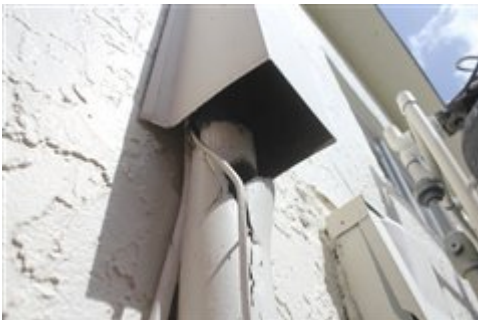
**Photo 19**

Encasement for refrigerant lines needs to be sealed to prevent insects, rodents, or and/or birds from entering the attic.

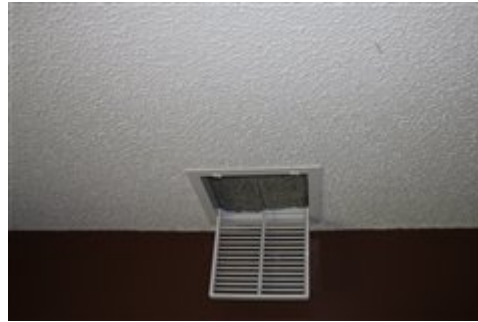
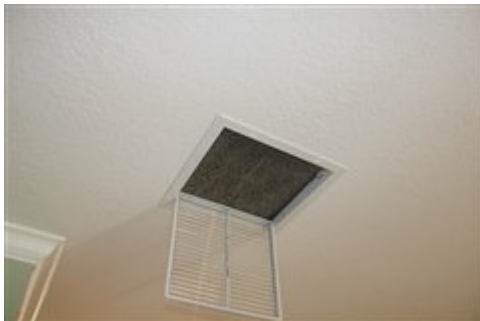
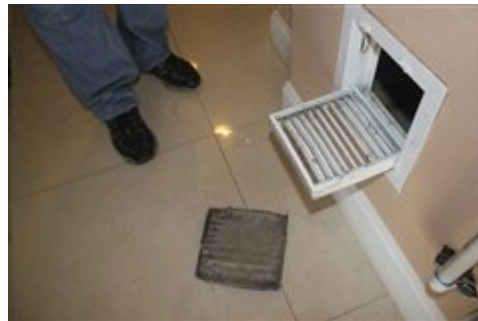
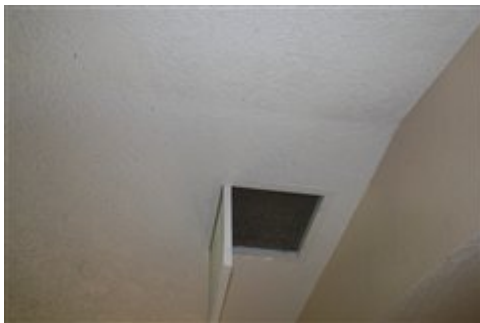
One or more air filters were dirty. A qualified person should replace filter(s) as necessary. Filters should be checked monthly and maintained as necessary in the future.

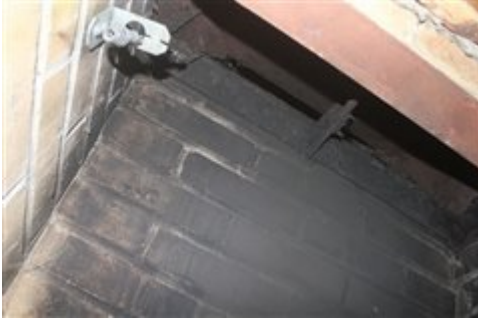
**Photo 156**

59) 🛠️🔍 Flue was inoperable. This is a safety issue. Have a qualified fireplace contractor evaluate and make the appropriate repair.  
*Cost estimate: \$ 250*

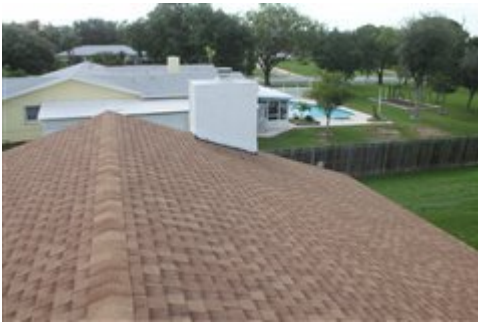
**Photo 107**

60) 🌿🔪 Vegetation was growing around the chimney and should be removed.

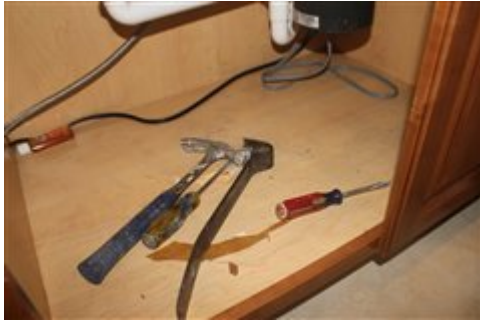
**Photo 150**

One or more sinks drains were clogged. A qualified plumber should evaluate and repair as necessary.

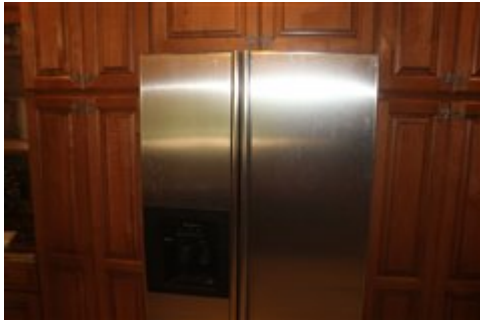
**Photo 149**

The refrigerator was inoperable. A qualified person should evaluate and repair as necessary, or the refrigerator may need replacing.

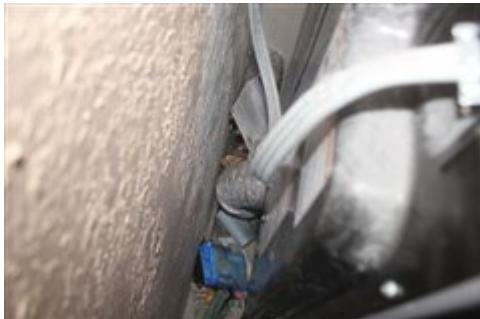
**Photo 171**

The clothes dryer was equipped with a foil, accordion-type, flexible exhaust duct. The U.S. Consumer Product Safety Commission considers these types of ducts to be unsafe, and a fire hazard. These types of ducts can trap lint and are susceptible to kinks or crushing, which can greatly reduce the air flow. This duct should be replaced with a rigid or corrugated semi-rigid metal duct, and by a qualified contractor if necessary. Most clothes dryer manufacturers specify the use of a rigid or corrugated semi-rigid metal duct. For more information on dryer safety issues, visit:

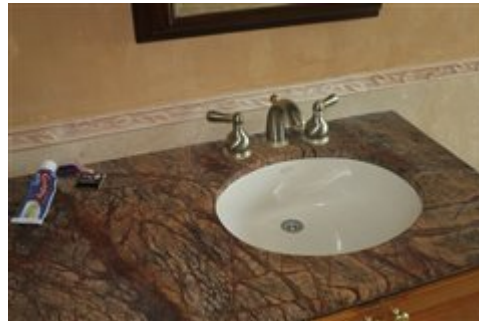
**Photo 120**

One or more sink faucet handles at location #A were loose. The sink on the left side control valves were installed in a reverse. A qualified plumber should repair or replace as necessary.  
*Cost estimate: \$ 400*

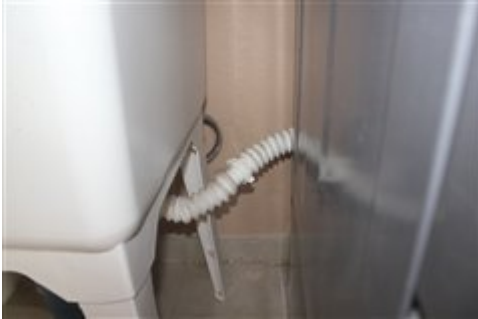
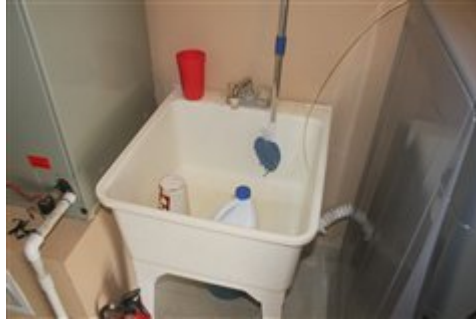
The sink drain at location #C used flexible drain pipe. This type of drain pipe is more likely to clog than smooth wall pipe. Recommend having a qualified plumber replace this pipe with standard plumbing components (smooth wall pipe) to prevent clogged drains.

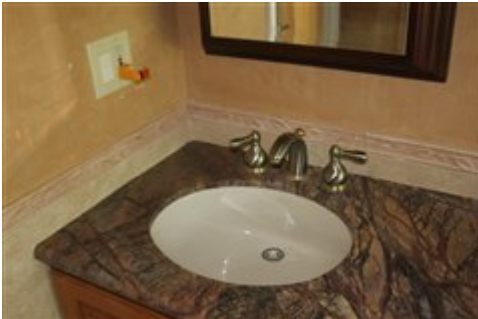
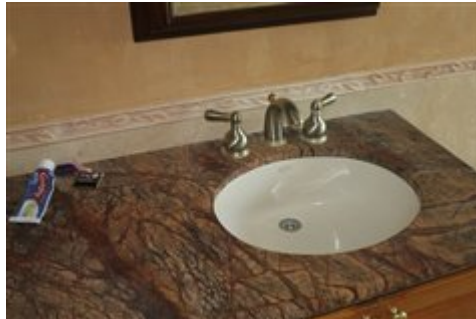
The sink drain stopper mechanism at location #A was missing and or damaged. A qualified plumber should repair or replace as necessary.

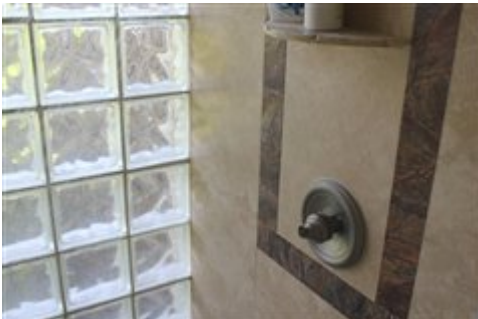
**Photo 121**

One or more shower faucet handles at location #A were missing. A qualified plumber should repair or replace as necessary.

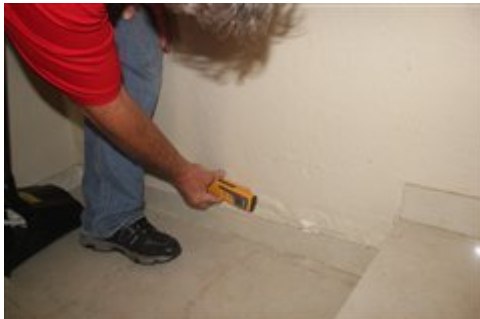
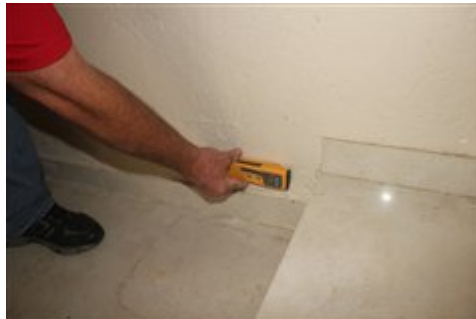
Evidence of moisture penetration in one or more interior walls. Client should check with Seller to determine source of moisture and take the necessary steps to eliminate source. Once done, walls should be re-painted and sealed.

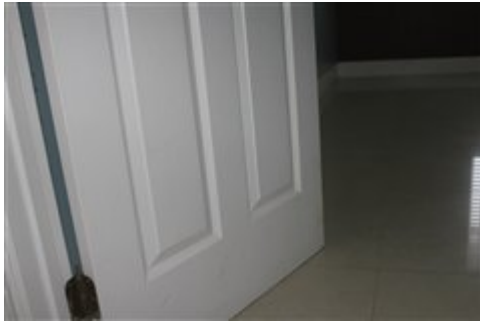
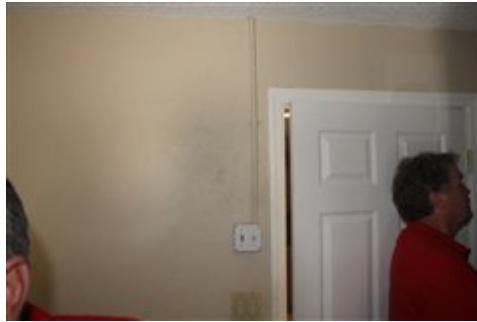
Some interior doors were sticking, were misaligned. A qualified person should evaluate and repair as necessary.

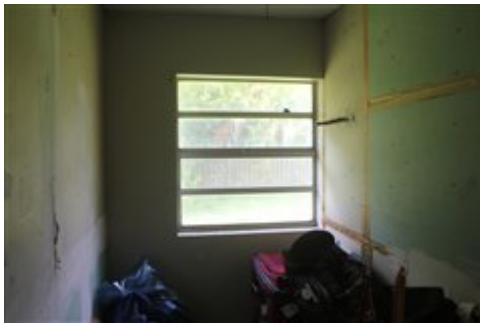
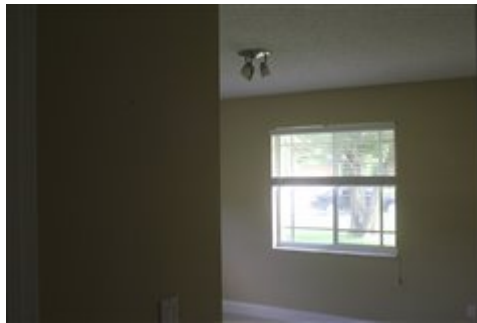
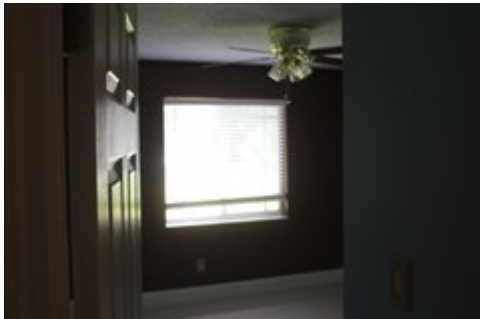
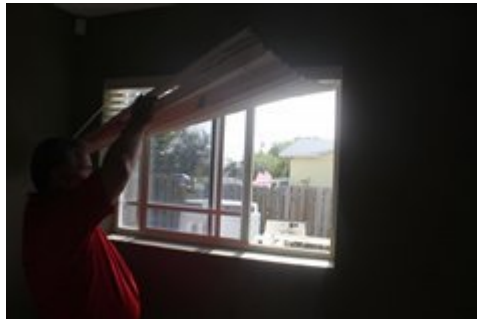
Many windows that were built to open were difficult to open and close. A qualified person should evaluate and repair as necessary.

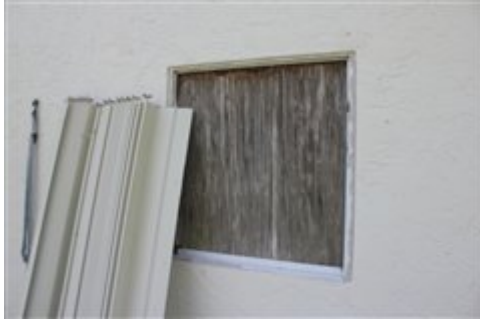
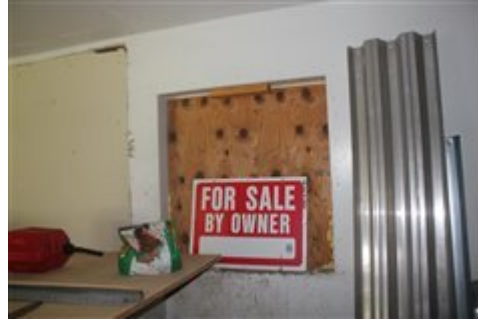
Some windows were missing. A qualified person should evaluate and repair or replace as necessary.

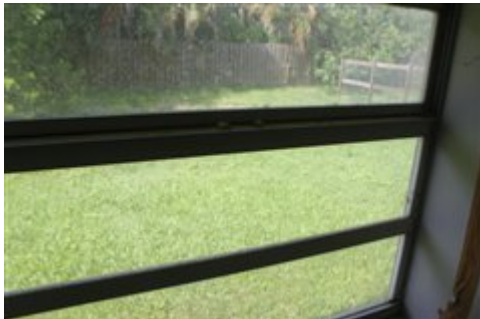
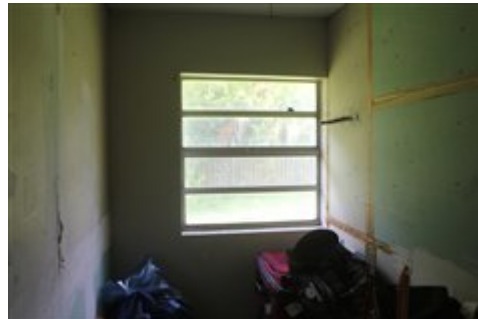
Lock mechanisms on some windows were damaged. A qualified person should repair as necessary.

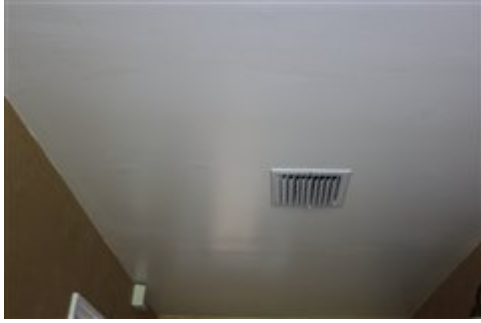
**Photo 123**

Substandard repairs were found in one or more ceiling sections. Recommend asking the property owner about the repairs, and having a qualified person repair as per standard building practices.

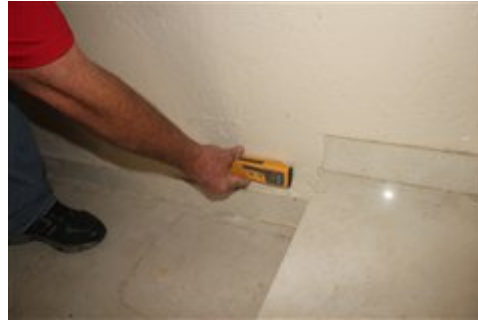
**Photo 173**

Note: Moisture left unattended for more than 72 hours can lead to mold growth. If evidence of mold is located inside the wall cavity, then mold assessment, testing and remediation steps will need to be taken at additional cost.

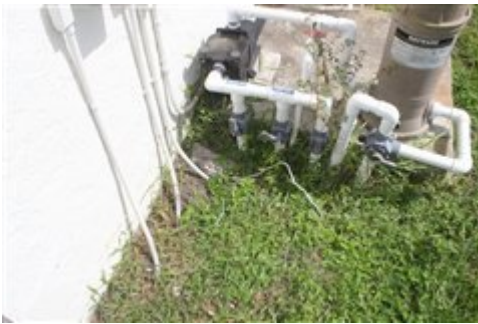
**Photo 23**

81) 🚧🔍 One or more sections of non-metallic sheathed wiring was routed so it was subject to physical damage, or it was not rated for outdoor exposure and was subject to sunlight or moisture. This is a potential safety hazard due to the risk of shock or fire. A qualified electrician should evaluate and repair as necessary and as per standard building practices. For example, by installing conduit.

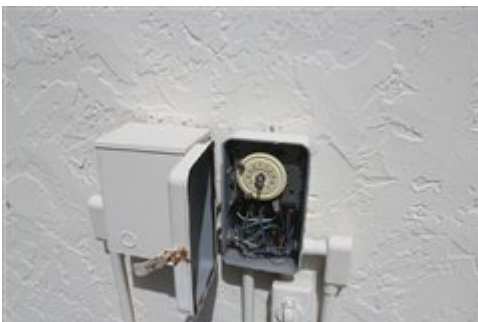
**Photo 26**

82) 🚧🔍 Wiring was exposed inside the timer box because the cover inside the box was missing. This is a safety hazard for shock. A qualified person should repair as necessary. For example, by installing a new cover.

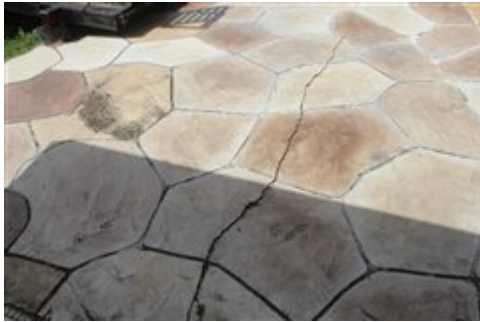
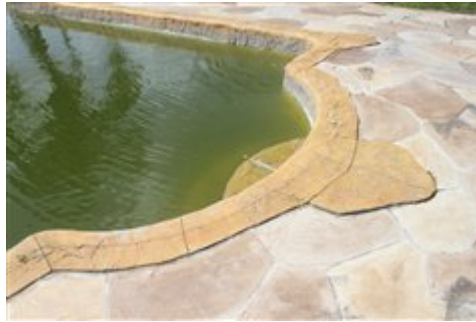
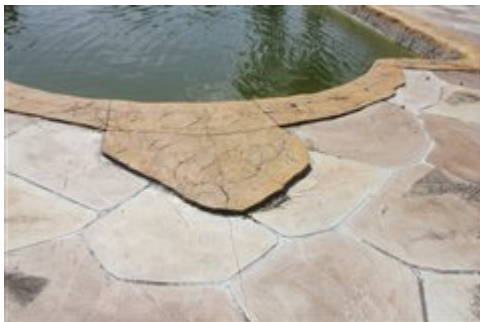
83) 🚧🔍 One or more trip hazards were found in the decking due to cracks, settlement, heaving and/or deterioration. There were gaps and deviation that indicates signs of lack of

reinforcement in the concrete slab. A qualified contractor should evaluate and repair or replace sections as necessary to eliminate trip hazards.

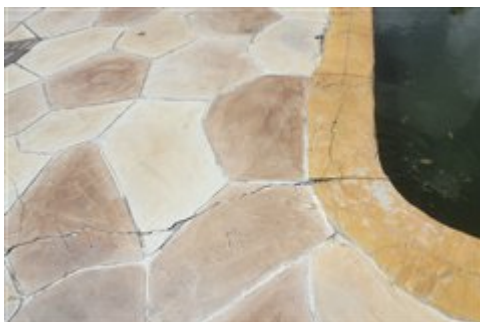
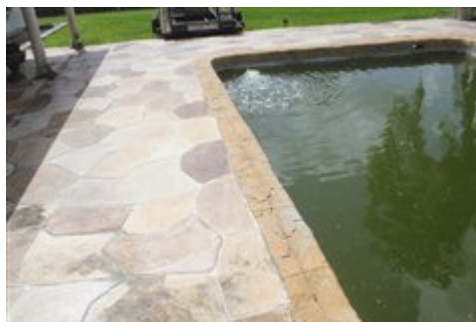
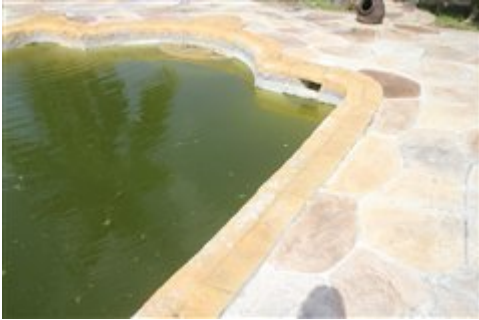
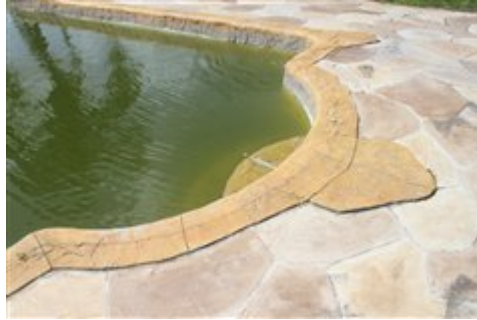
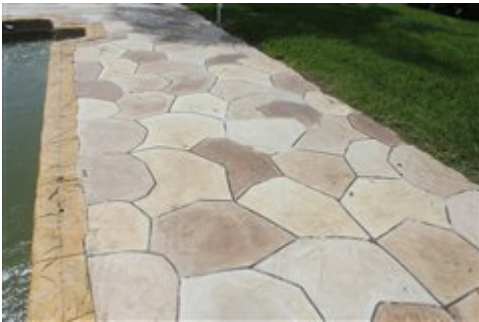
The concrete in sections of the pool coping was cracked and separating from the pool. A qualified contractor should evaluate and make the appropriate repair and or replacement. For more information, visit: [http://www.poolcenter.com/coping\\_page\\_repair\\_and\\_costs.htm](http://www.poolcenter.com/coping_page_repair_and_costs.htm)

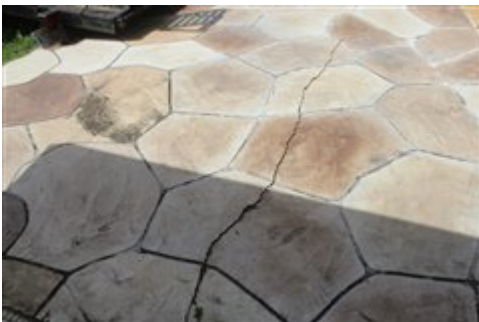
**Photo 33**

85) 🛠️ Due to the finish of the decking, it may be impossible to match the existing finish and it may require the complete refinishing of the patio and pool deck.

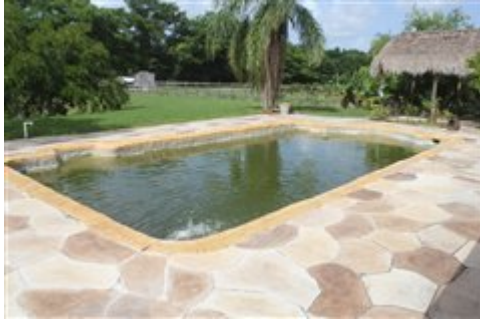
**Photo 96**

86) 🔍 The pool water level was low. The past couple of weeks, the South Florida area has had a significant amount of rain which in most cases has overfilled pools in the area. Based upon this information, the inspector believes the pool body or equipment may have leaks. A qualified pool contractor should evaluate to determine if repairs are necessary. For more information, visit:

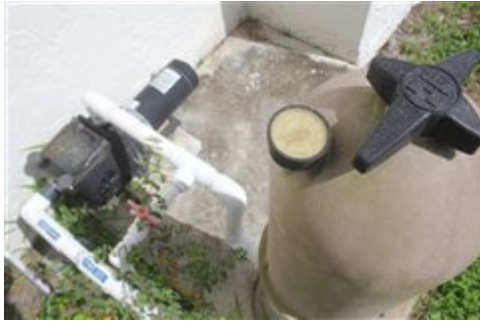
**Photo 25**

The filter pressure gauge was damaged. A qualified contractor should evaluate and repair as necessary.

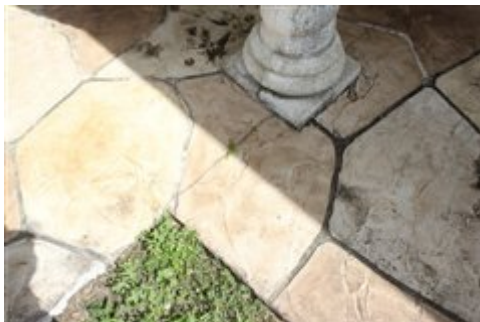
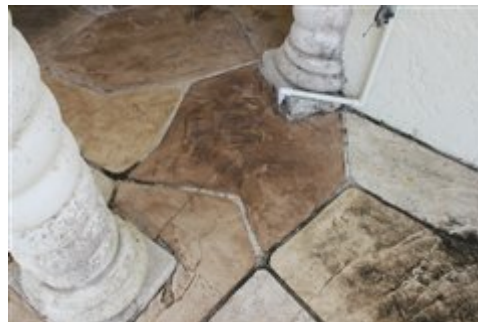
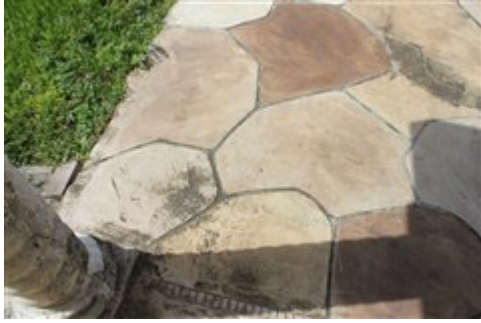
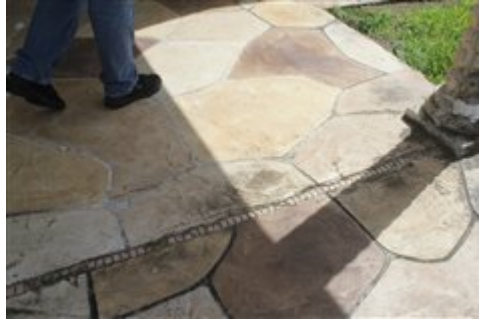
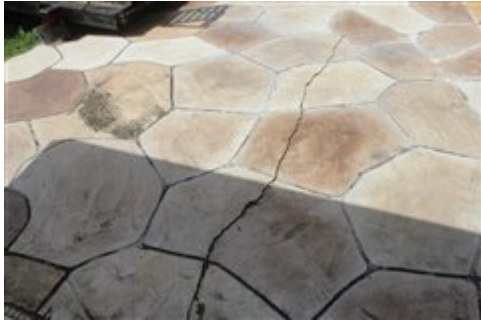
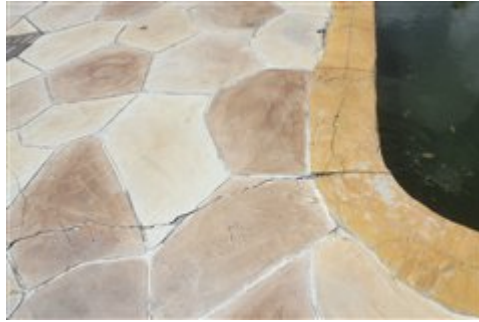
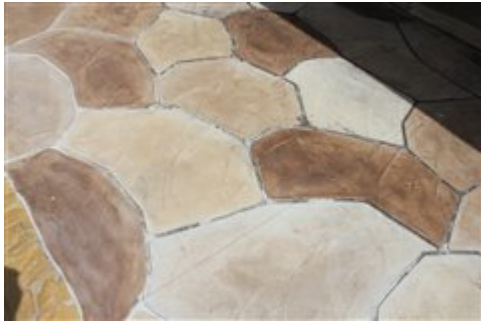
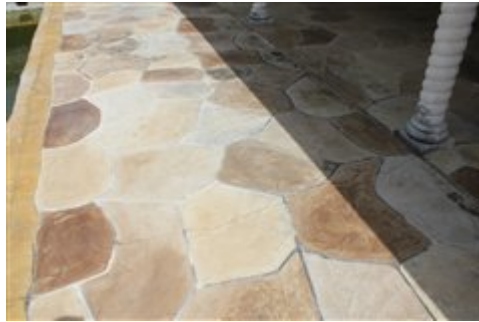
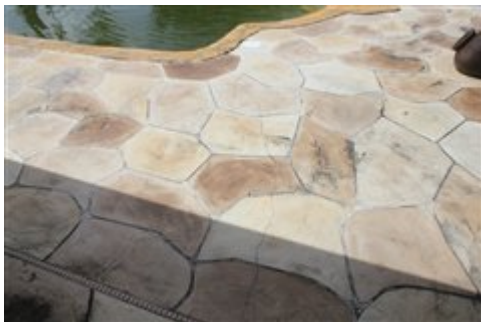
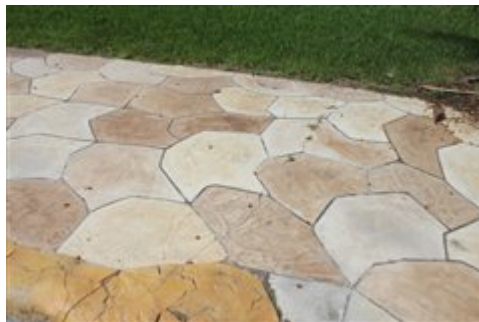
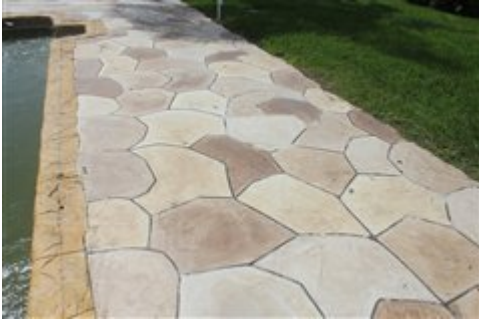
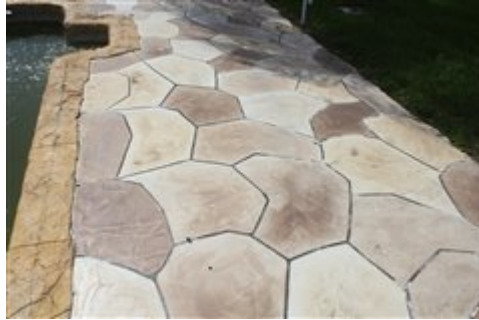
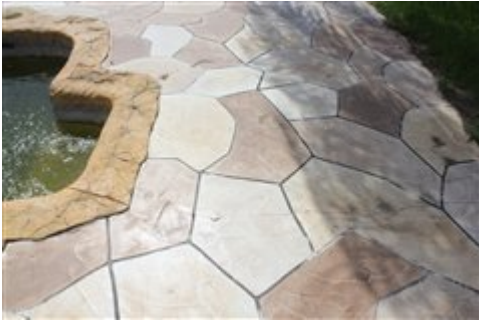
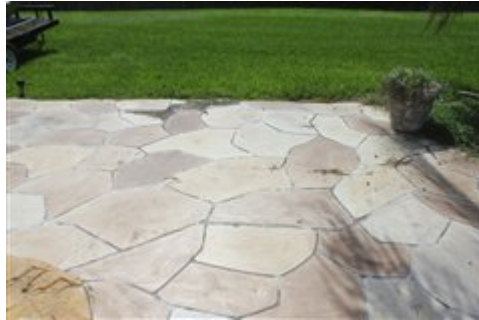
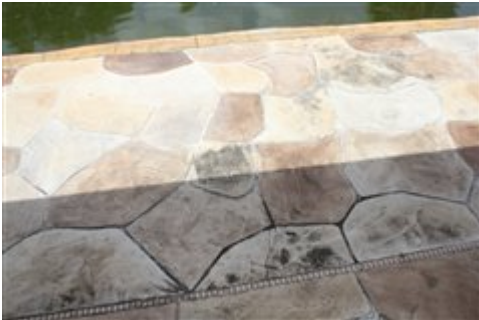
Numerous cracks, settlement, heaving and/or deterioration were found in the decking. Recommend that a qualified person caulk or seal cracks as necessary to prevent water intrusion and further cracking or movement.

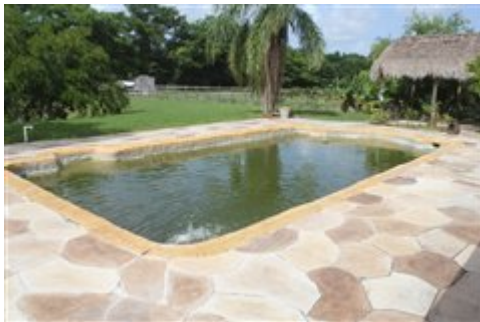
**Photo 96**

The presence of algae may indicate that the filtration system is undersized. Recommend consulting with a pool specialist. For more information, visit:

- Balancing the water, especially the pH.
- Checking the filter system and maintaining if necessary (backwash or replace medium, clean or replace cartridge, etc.)
- Running the filter system continuously until the water clears
- "Shocking" the pool with hypochlorite
- Brushing the walls and floor of the pool
- Draining the pool (in extreme cases)
- Applying an algaecide

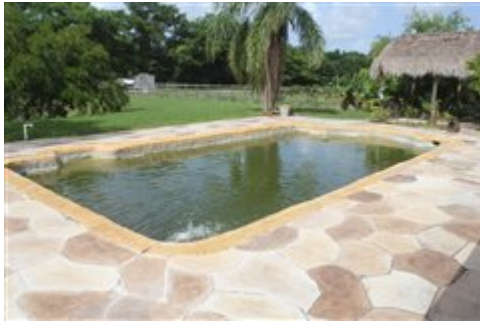
**Photo 96**

The swimming pool and its equipment were not fully evaluated because pool water was green. Recommend that a full evaluation be made by a qualified person when conditions have been corrected so the electricity supply is fully operable. Note that as per the standards of

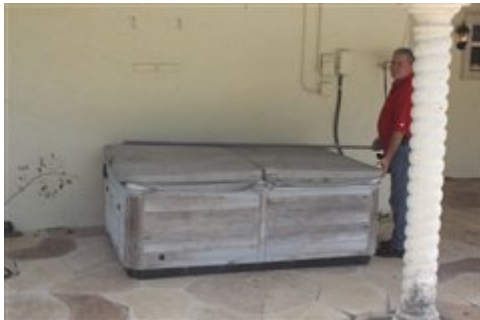
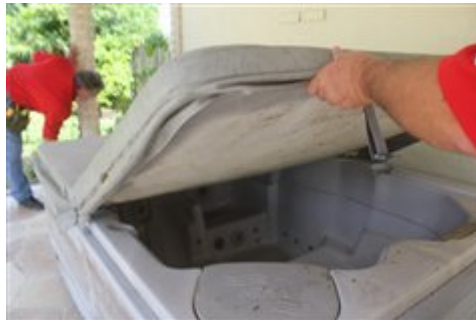
The portable spa had no water and was not evaluated.
